# SCHOOL BUILDING RENOVATION REPORT

## I. BUILDING BEFORE RENOVATION

## II. RENOVATION PROCESS

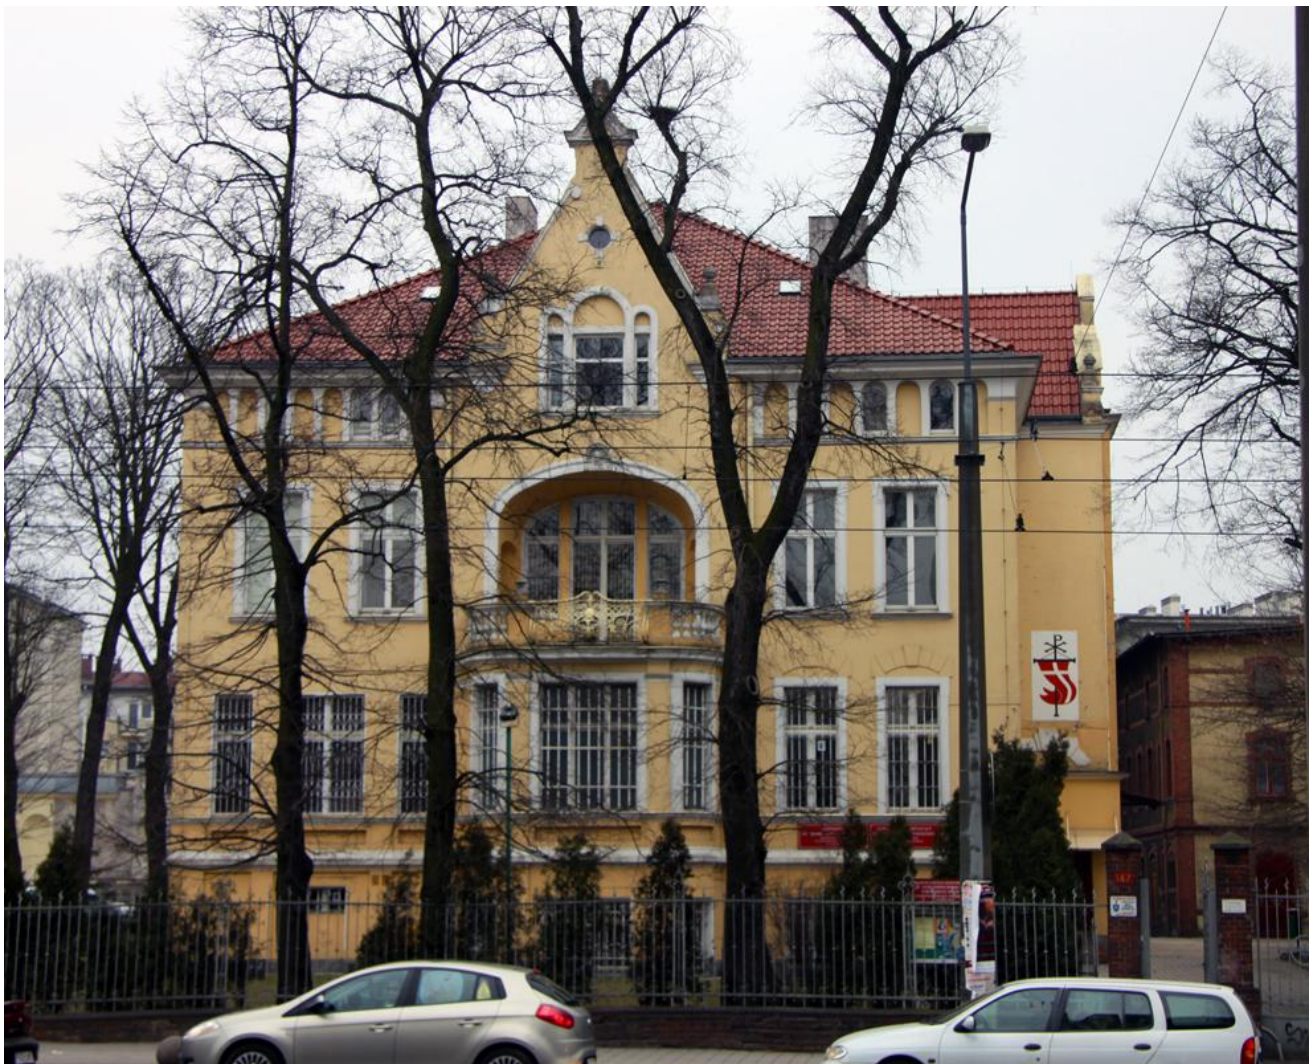
Figure 1. West view of building before renovation

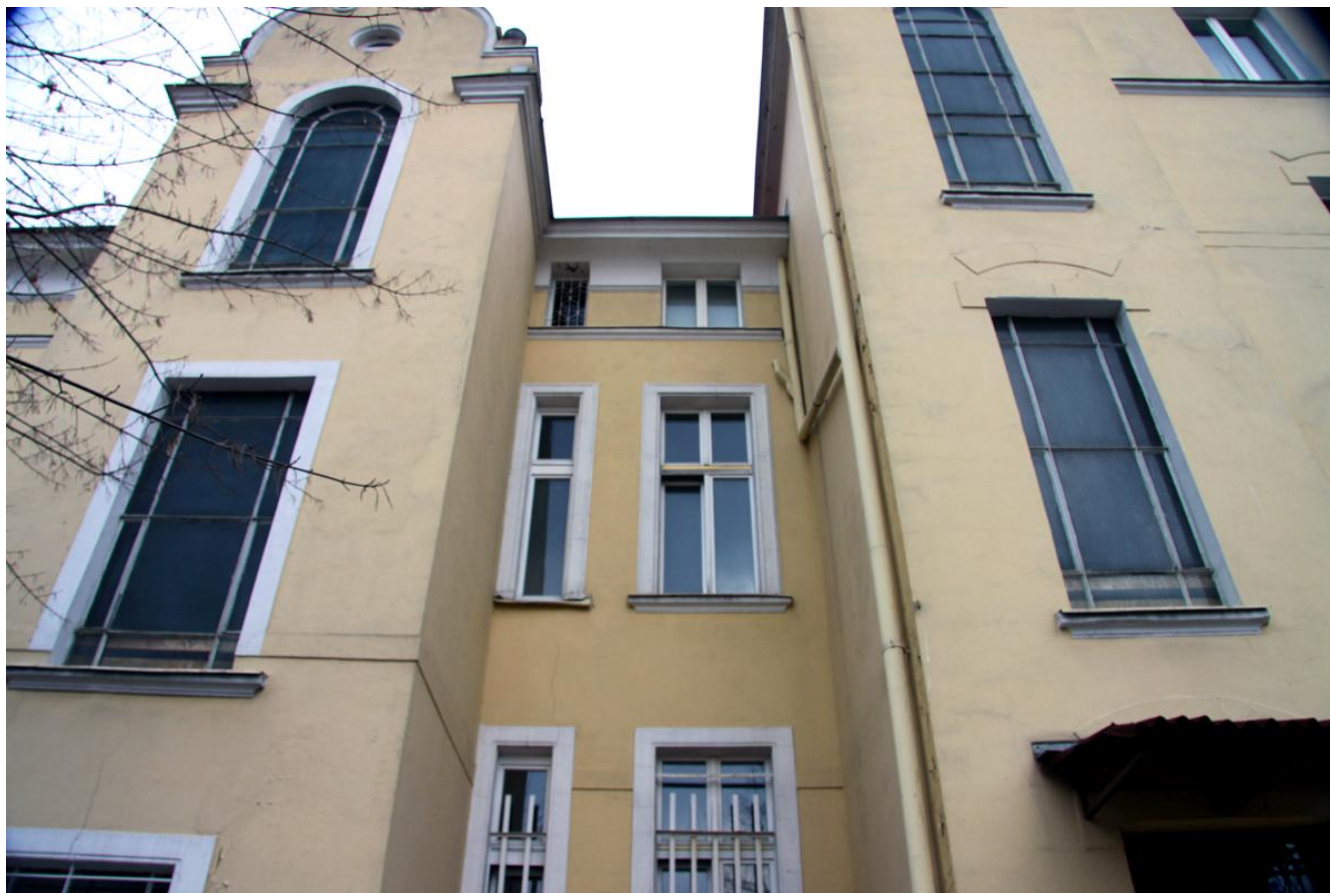
**Figure 2. South view of building before renovation**

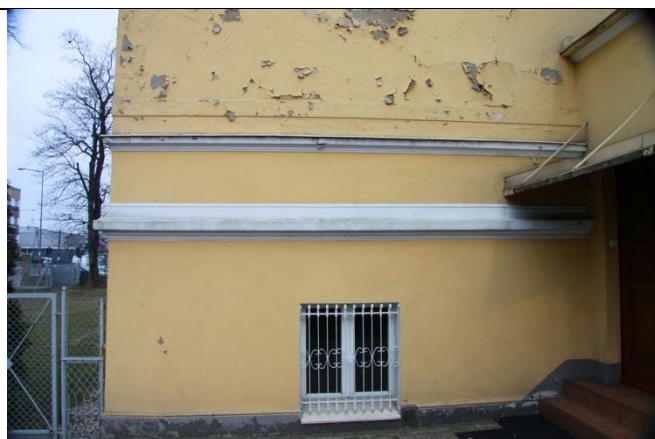
- year of renovation of the elevation – 1997,
- year of renovation of the roof – 2000,
- year of damp-proofing of walls – 2010,
- year of changing the windows of the south side of building – 2013,
- the plaster was falling off the walls, the north wall began to crack,
- drainpipes, flumes and windowsills were in bad condition,
- bars of the windows and balustrades of the balconies were suffered from corrosion,
- bathrooms and some other utility rooms were not connected to the ventilation system,
- stairways and terrace floor were not waterproof and balcony floors were destroyed,
- concreted band surrounding the building was not waterproof.

**Figure 3. condition of the plaster**

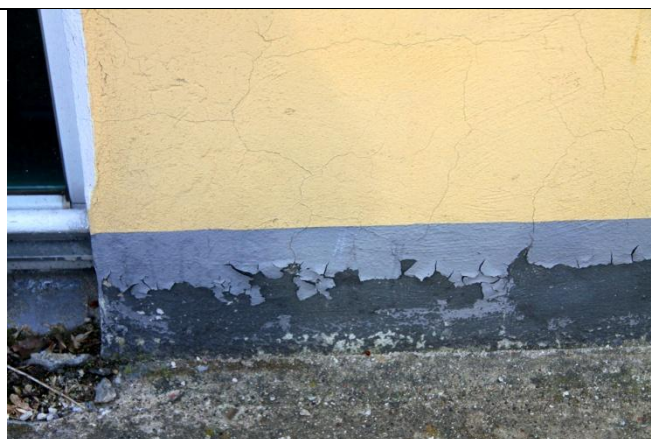
**Figure 4. condition in close-up**

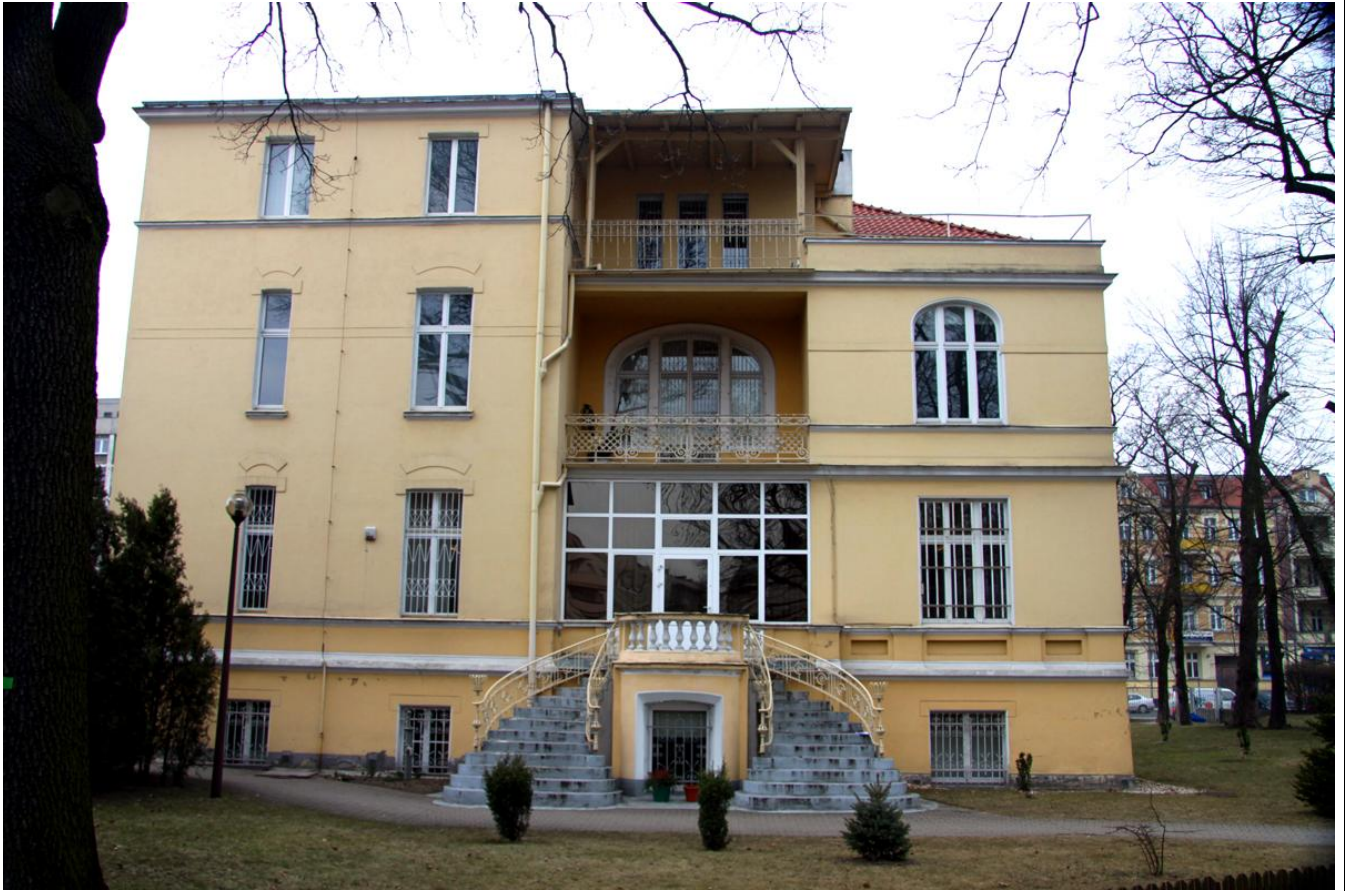
**Figure 5. East view of building before renovation**

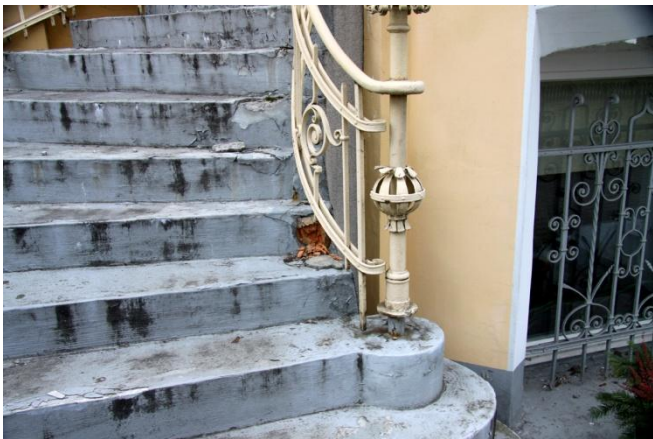
**Figure 6. terrace stairway and floor**

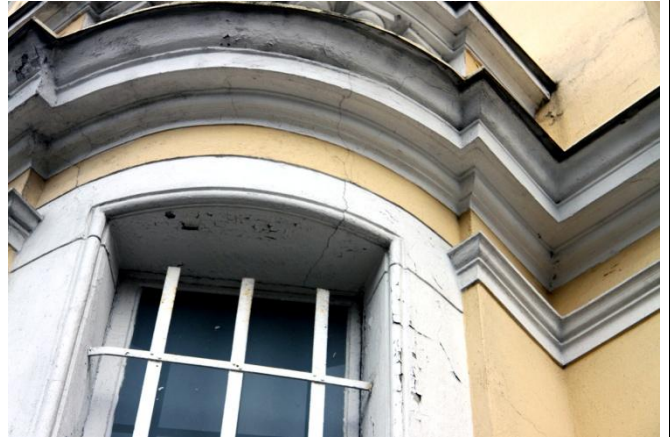
**Figure 7. condition in close-up**

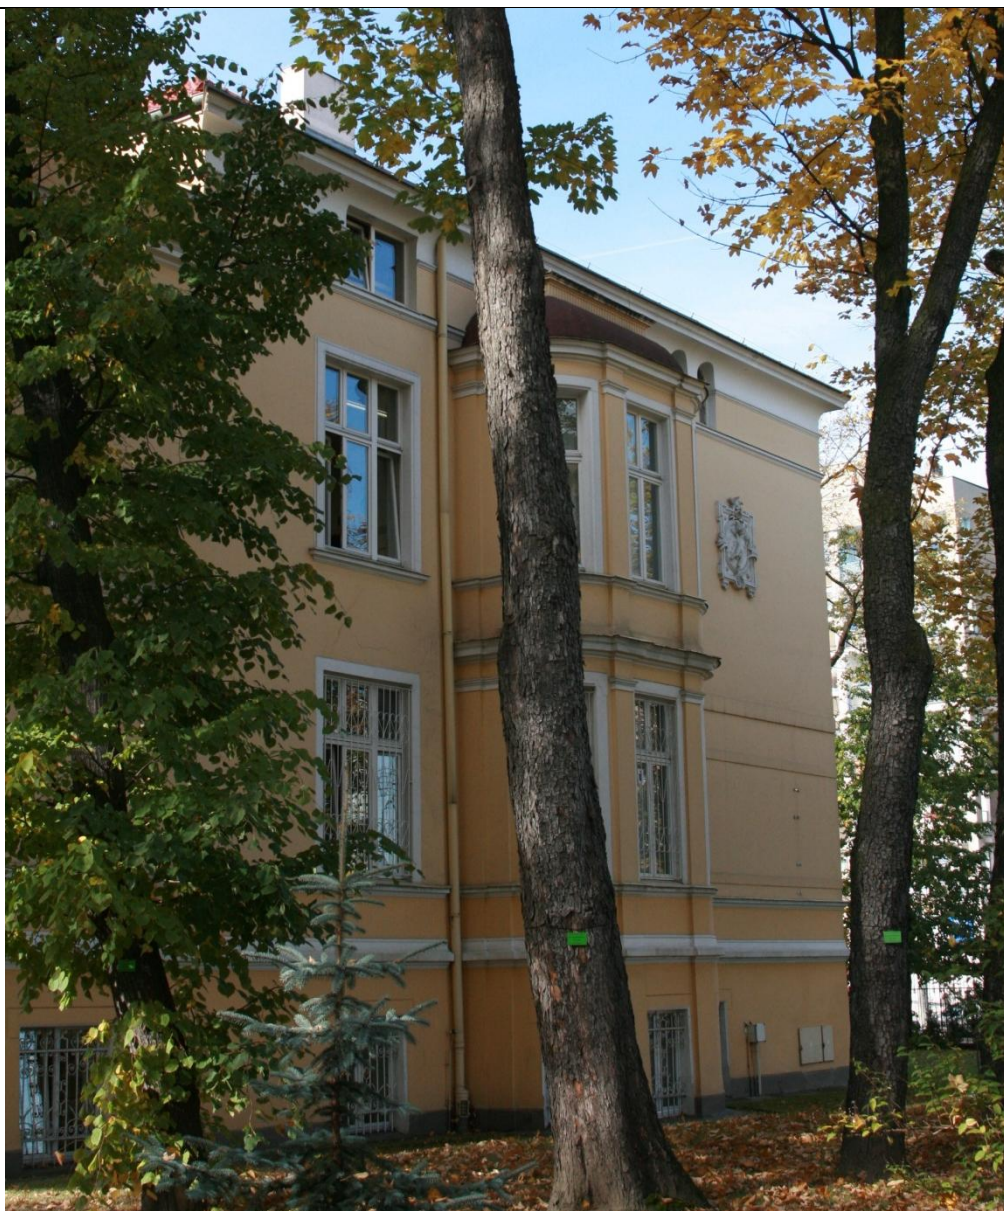
**Figure 8. North view of building before renovation**

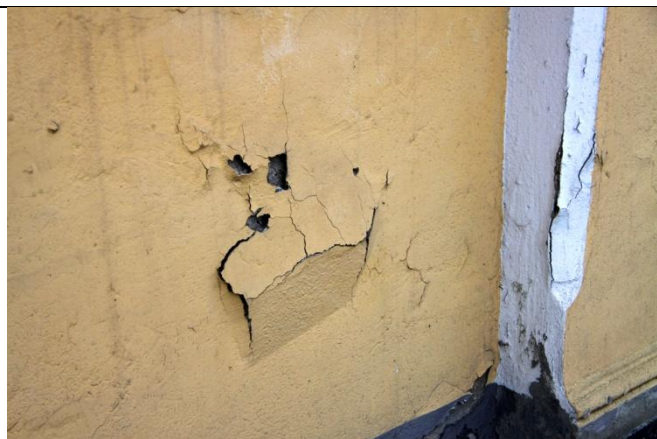
**Figure 9. condition of the plaster**

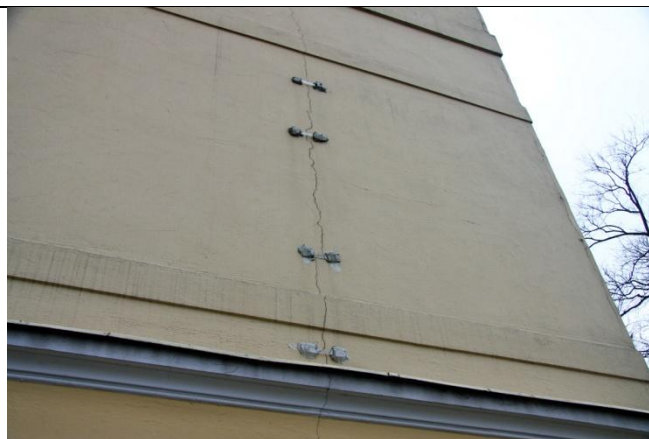
**Figure 10. the wall began to crack**

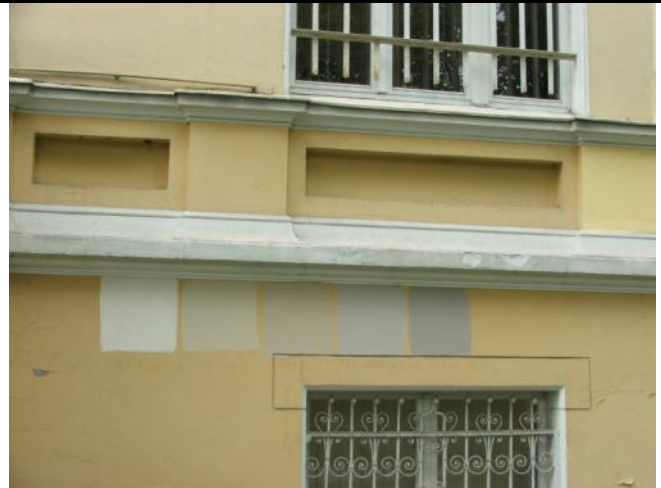
Figure 1 – color samples on the wall

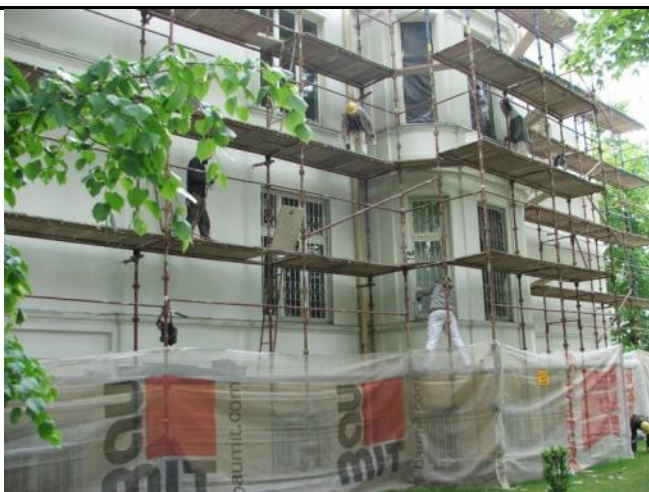
Figure 3 – repair work on the north wall of the building

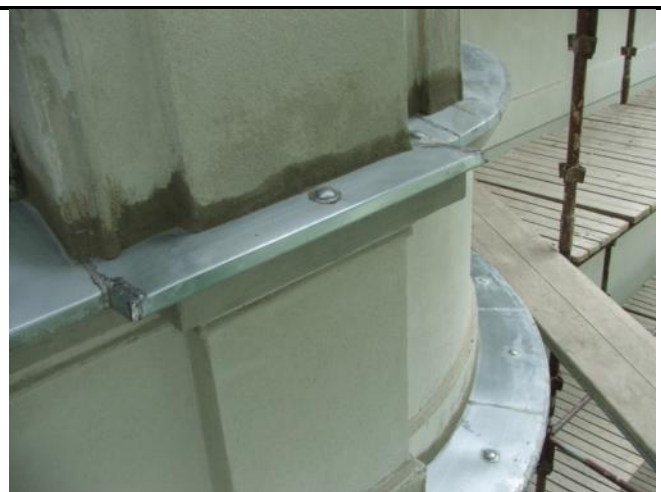
Figure 4 – plating cornices with tinplate

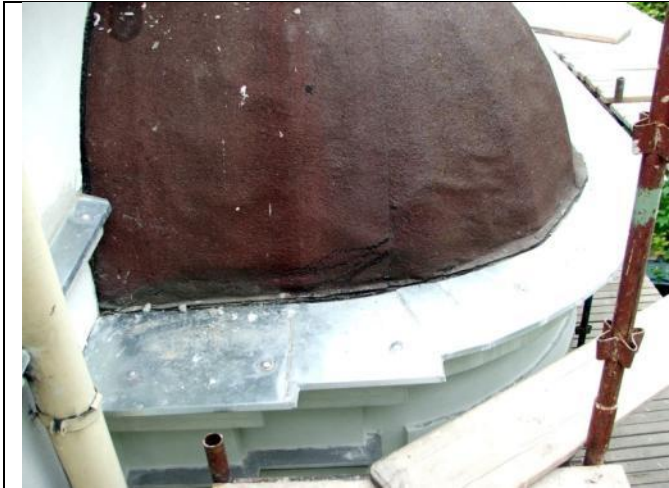
Figure 5 – the roof of the corner annex before renovation

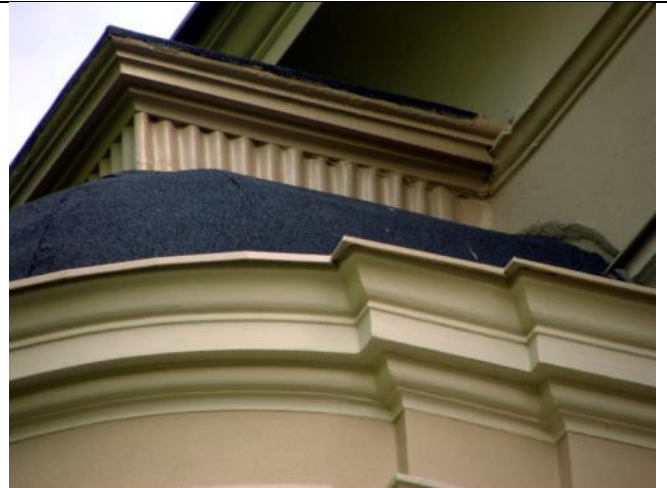
Figure 6 – a felted roofing of the corner annex

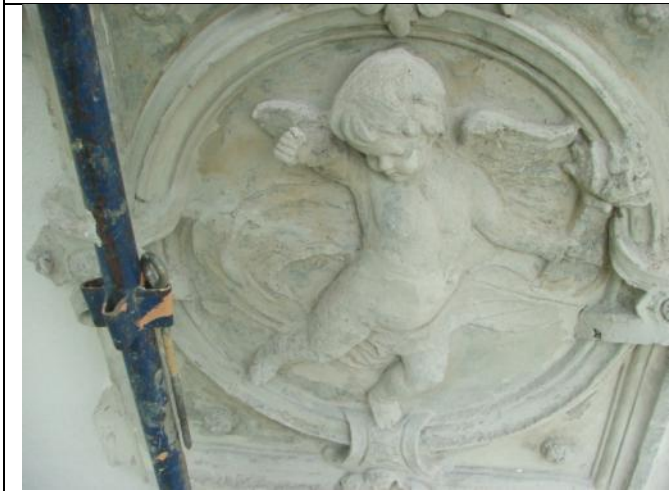
Figure 7 – the molding before renovation

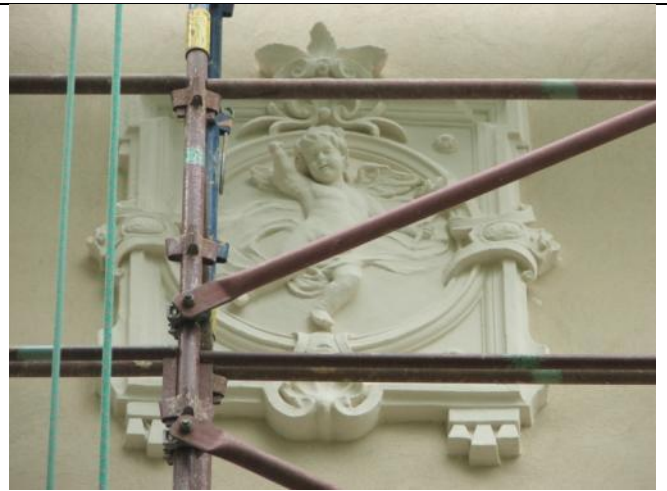
Figure 8 - the molding after the repair work

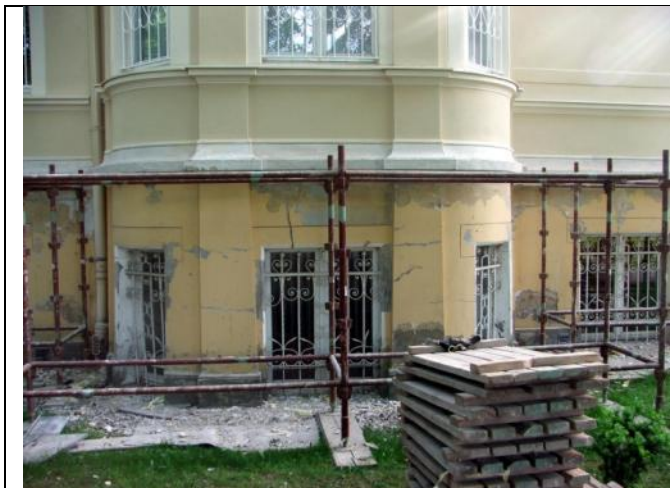
Figure 11– the base course of the building before renovation

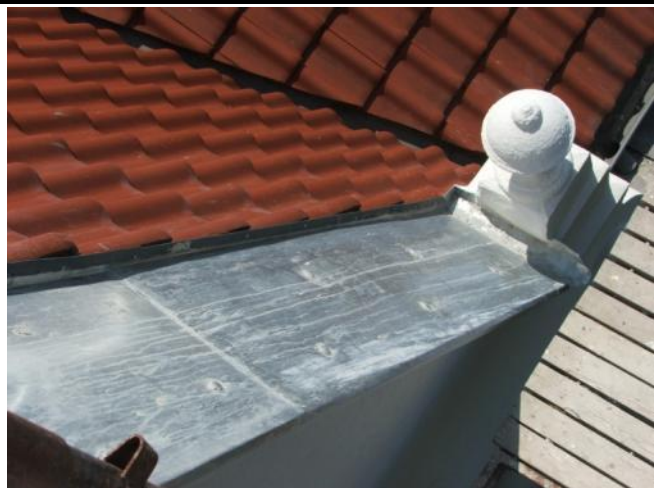
Figure 13 - plating coping with tinplate

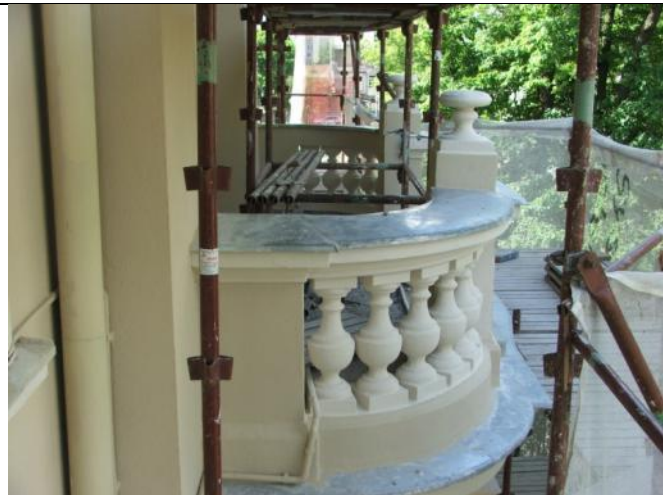
Figure 16 - balcony balustrade after painting

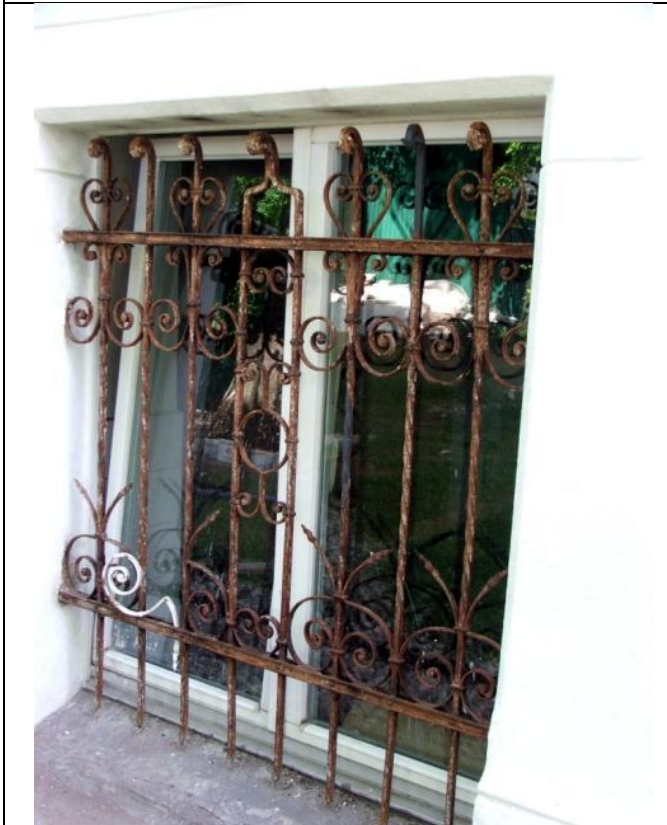
Figure 25 – antique window bar after heating

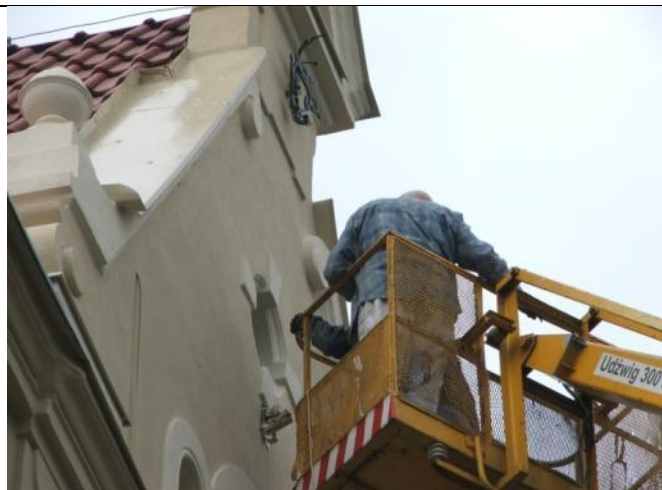
Figure 28 – painting decoration details and removing old flag handles on the west wall of the building - recommended by inspector in charge of the renovation (24.06.2014)

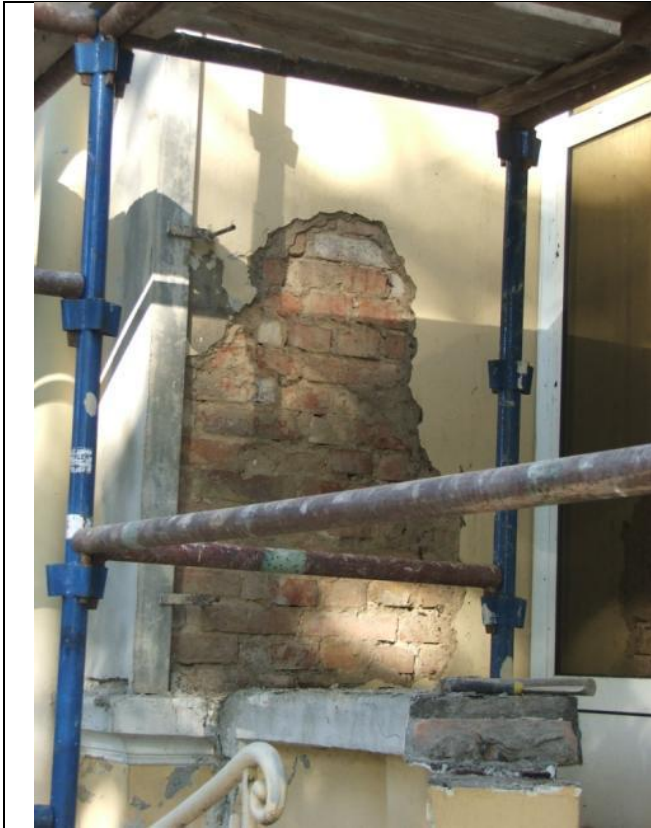
Figure 31 – the east wall, hacking the bad plaster off

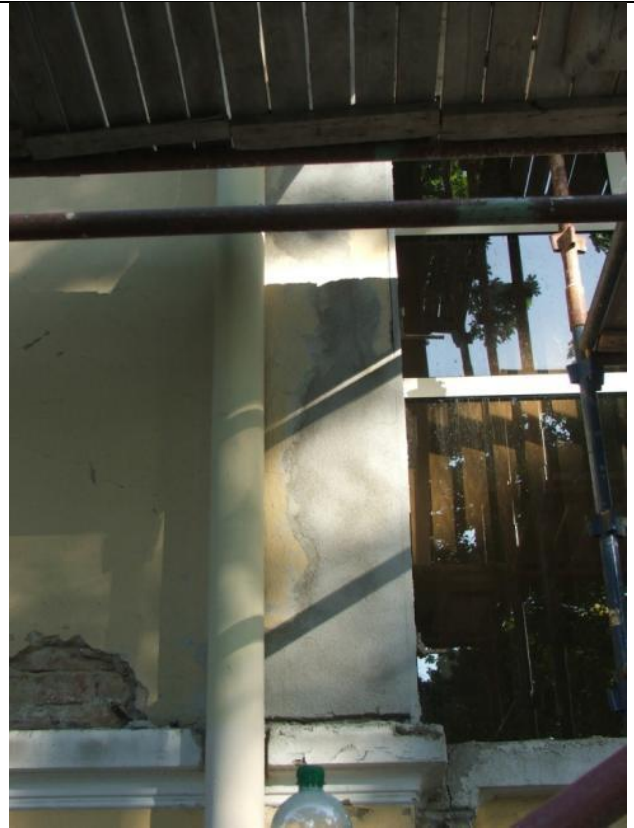
Figure 32 – repair work on the east wall

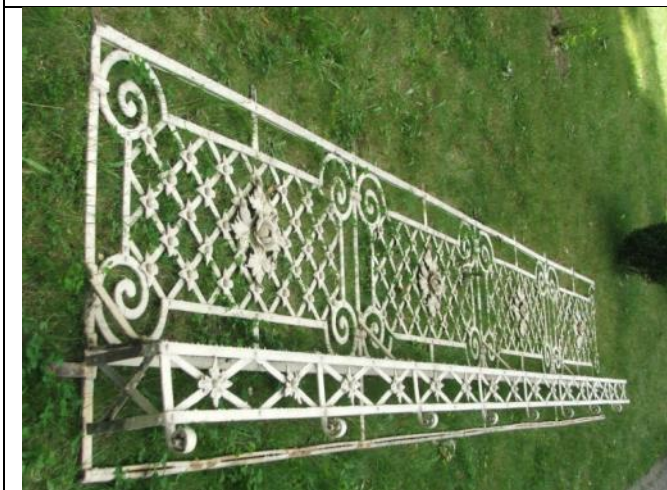
Figure 35 – balcony balustrade cut for sandblasting

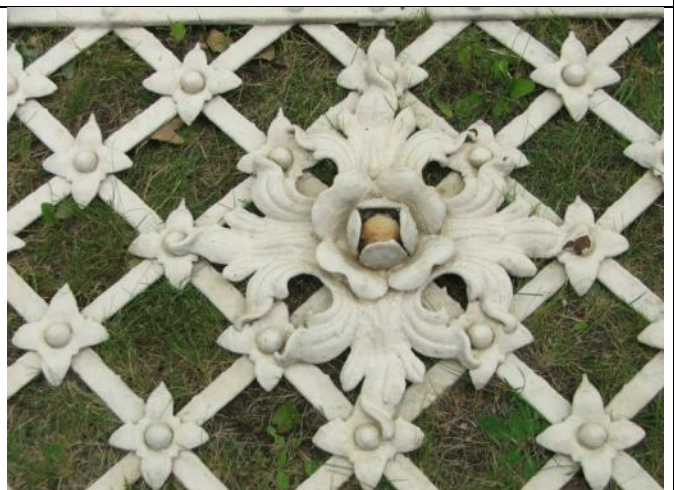
Figure 36 – part of balcony balustrade suffering from corrosion

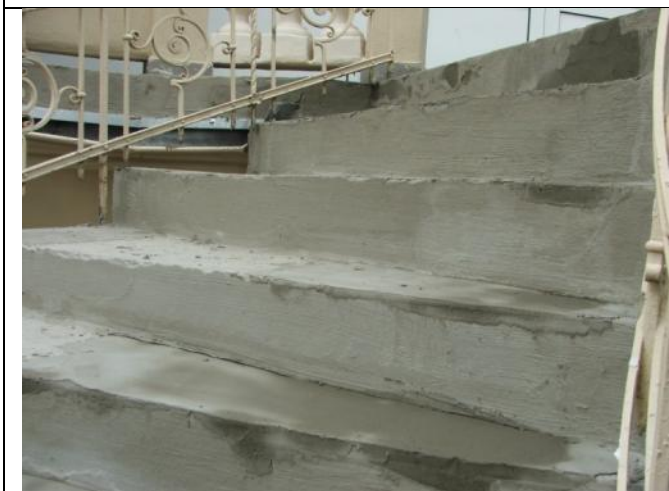
Figure 53 – the first layer of insulation against water on the terrace stairs

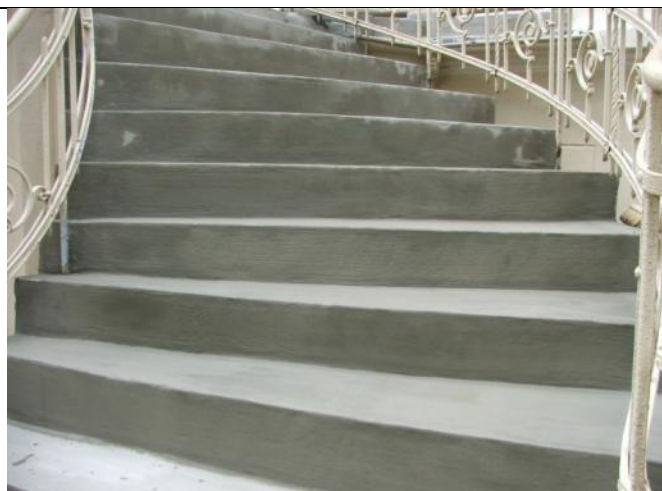
Figure 54 – the second layer of insulation against water on the terrace stairs

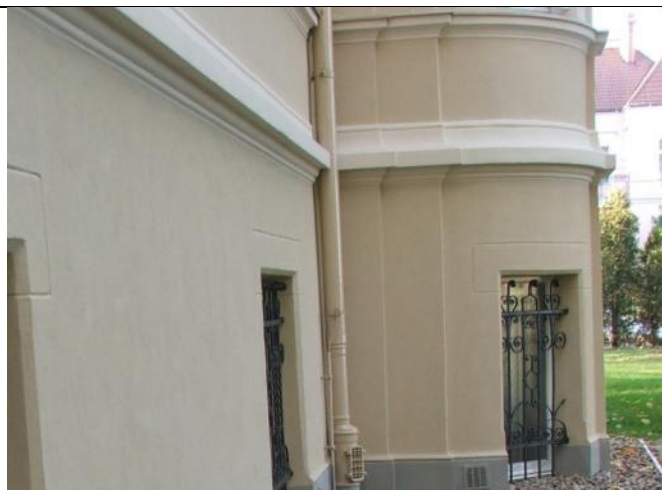
Figure 56 – the new waterproof concreted band surrounding the building
