# SCHOOL BUILDING RENOVATION REPORT

## I. BUILDING BEFORE RENOVATION

## II. RENOVATION PROCESS

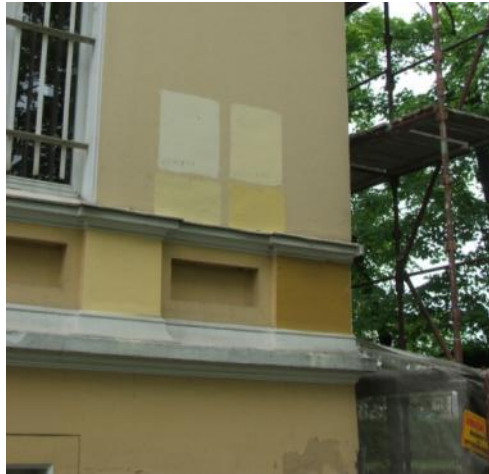
Figure 1 – color samples on the wall

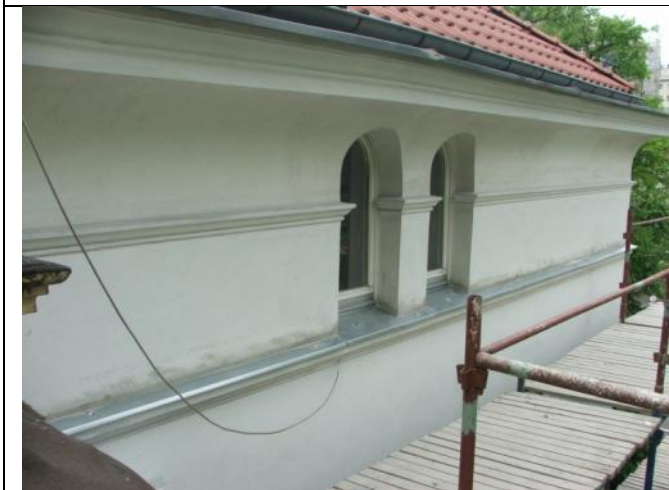
Figure 9 – attics on the north wall of the building

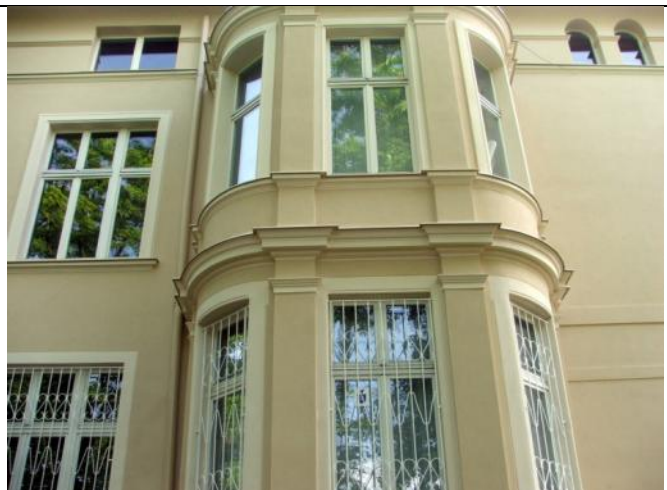
Figure 10 – view of the north wall of the building after renovation

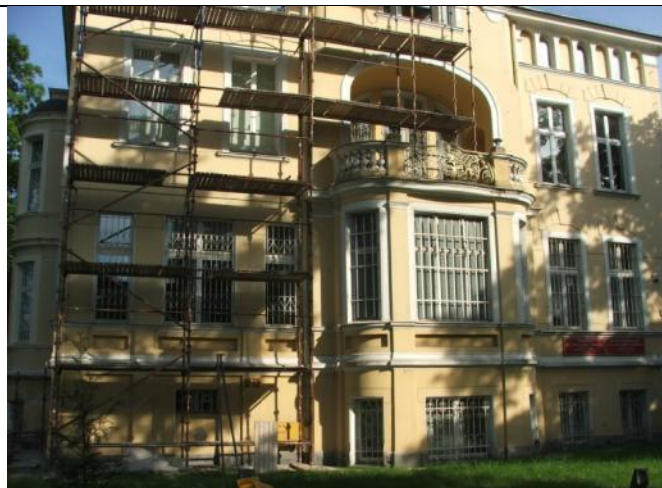
Figure 12 – (21.05.2014) Setting up the scaffolding along the west wall of the school building

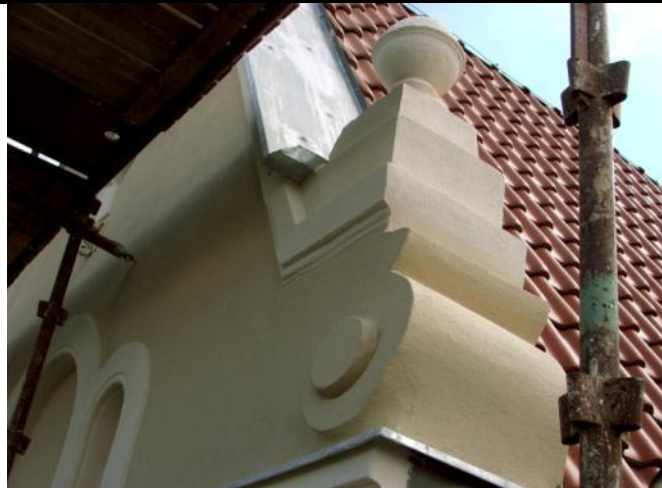
Figure 14 – the coping decoration

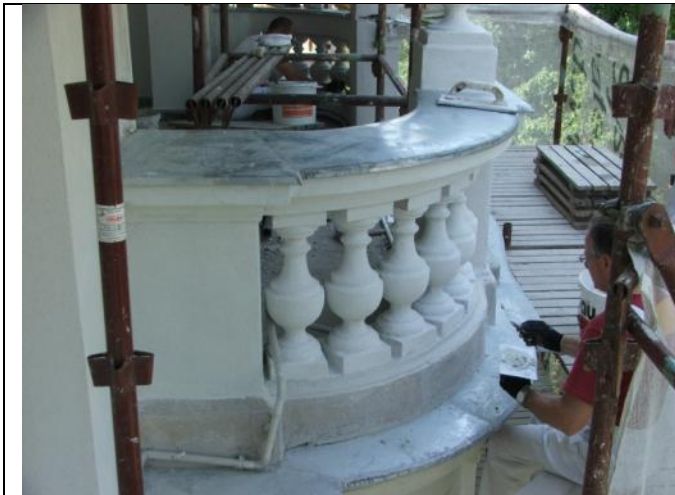
Figure 15 - balustrade of the balcony

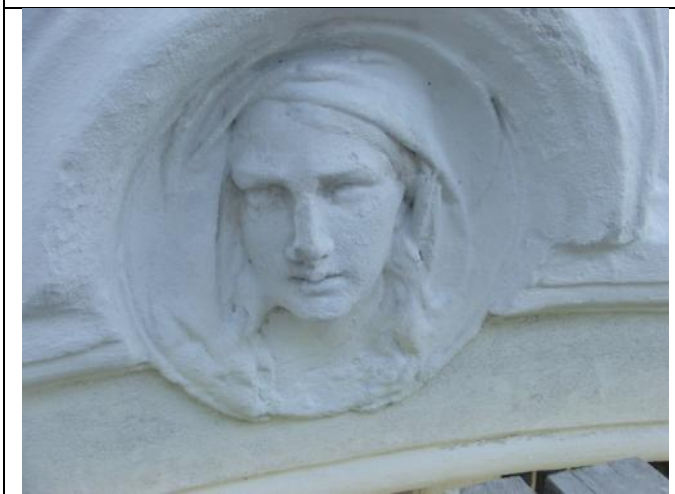
Figure 17- the medallion above loggia

1. Renovation of the medallion above loggia, cornices and other architectural details.
2. Changing or reparation drainpipes, flumes and windowsills. Continuation of roofing works also.
3. Cleaning balustrade of the balcony by sandblasting and cleaning antique bars of windows by heating.
4. Setting-up the scaffolding by the east wall of school building and beginning of the repair work, among other things: hacking the bad plaster off, repairing hacked surfaces by applying the BASF technology, preparation balustrades of the balconies for sandblasting, start-up repair works on terrace.

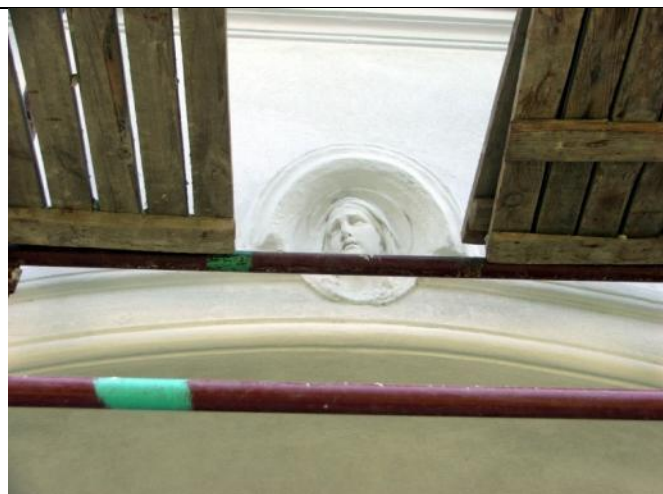
Figure 18 - the medallion above loggia

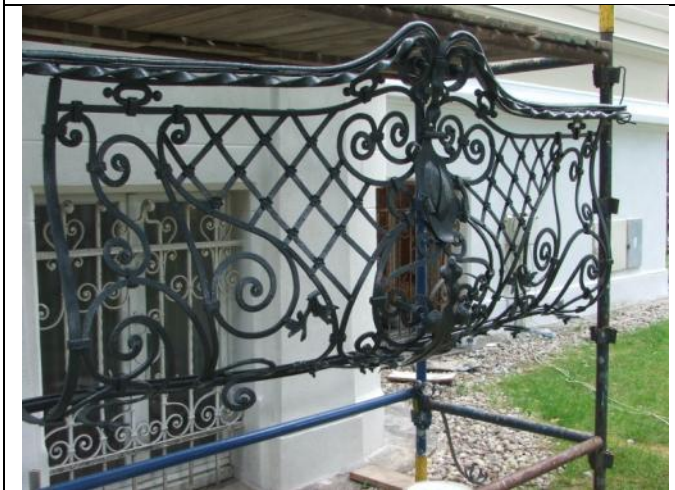
Figure 19 – balustrade of the balcony after sandblasting and painting

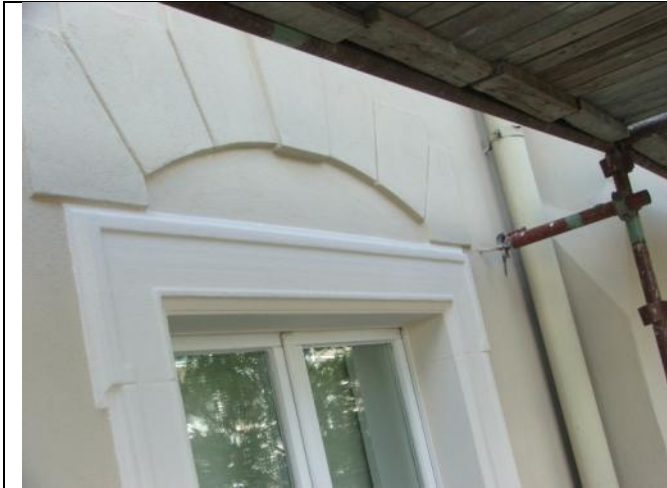
Figure 21– decoration of the windows

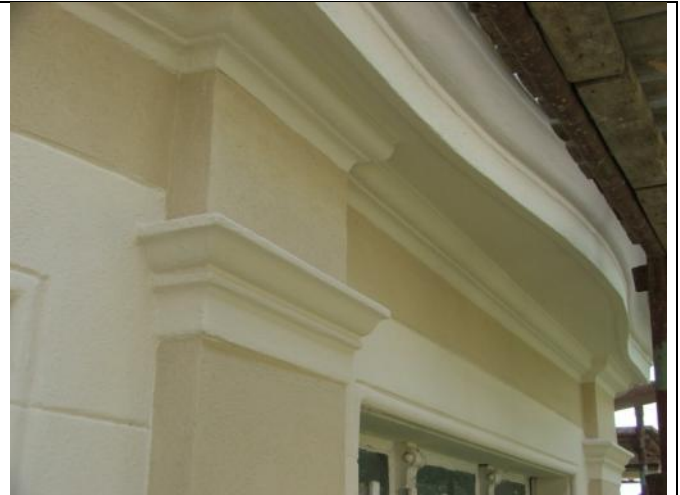
Figure 22 – cornices and other west wall decoration

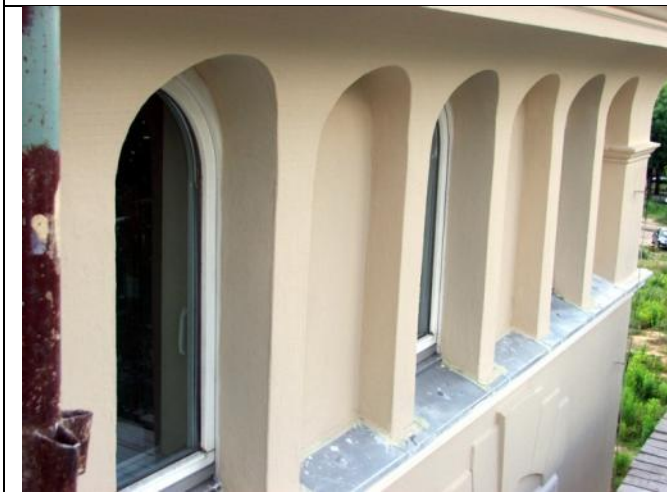
Figure 23 – attics on the west wall of the building

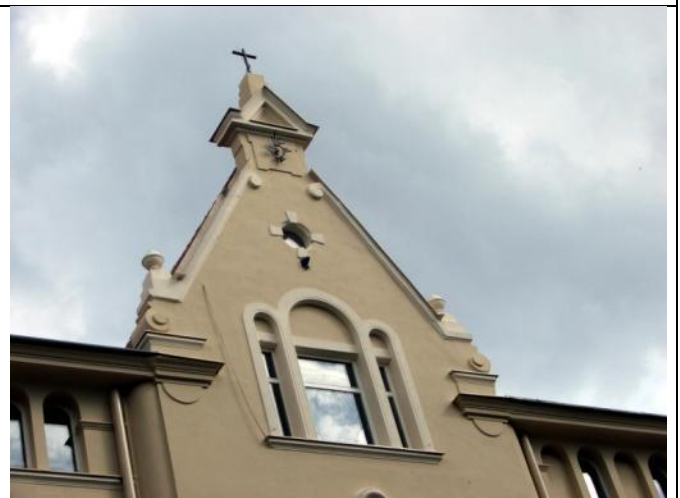
Figure 24 – coping on the west wall of the building

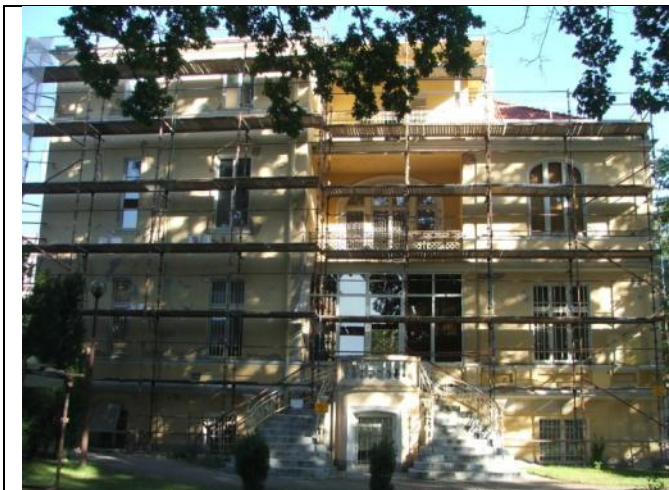
Figure 27 – Setting up the scaffolding by the east wall of the school building (23.06.2014)

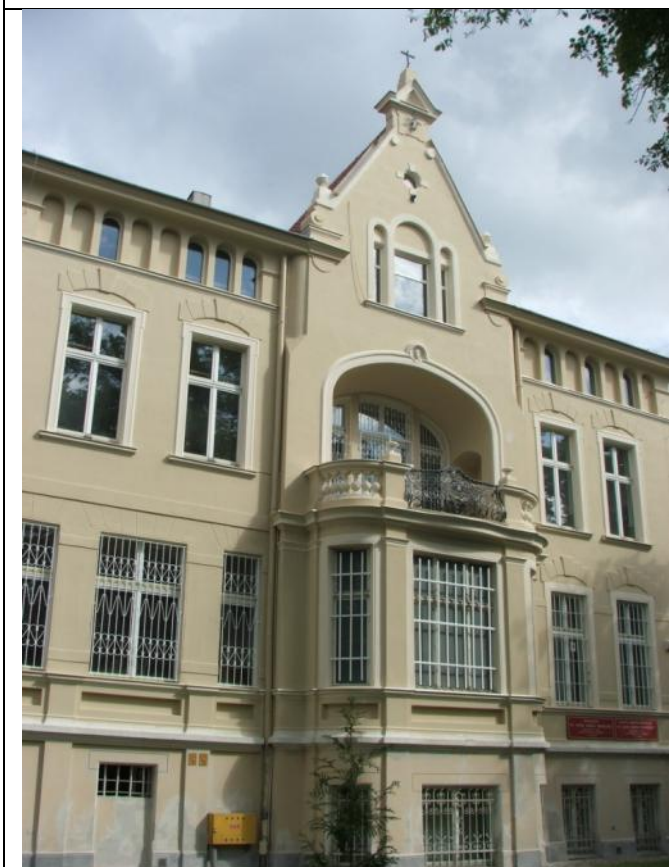
Figure 29 – the east wall of the school building before changing chapel windows

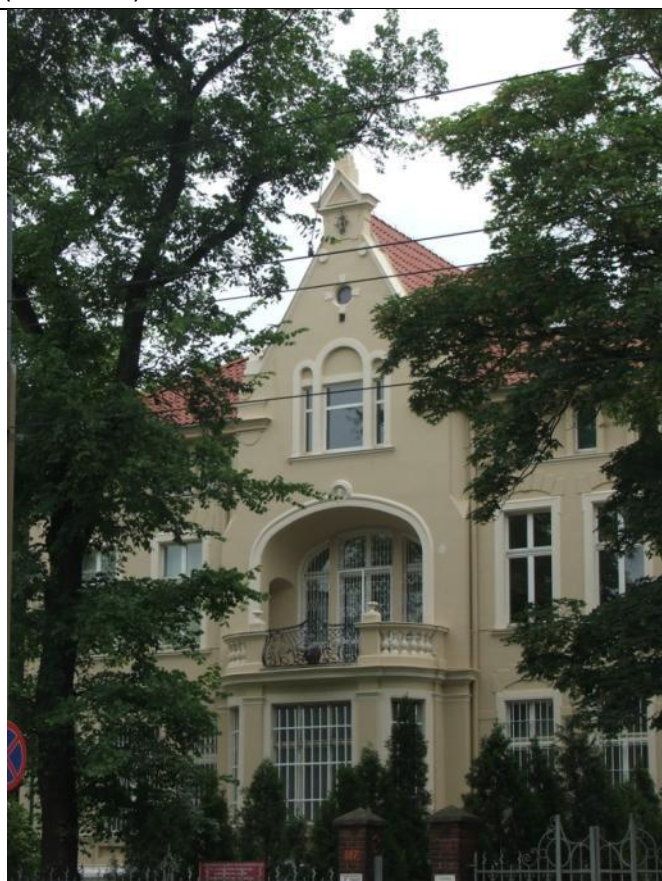
Figure 30 – the east wall of the school building, view from Głogowska street

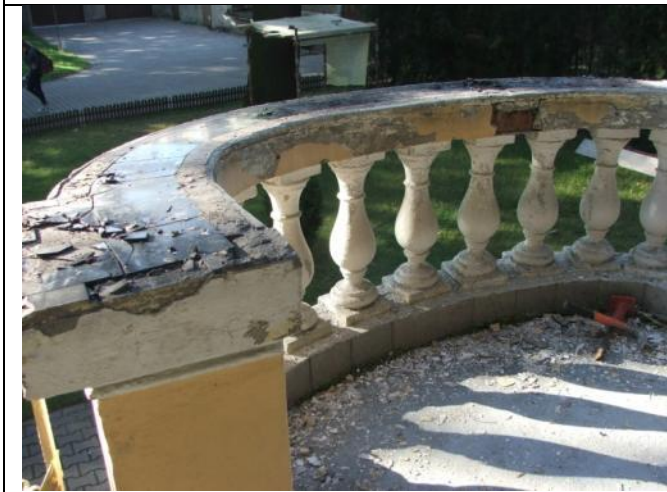
Figure 33 – the east wall, repair works on the terrace

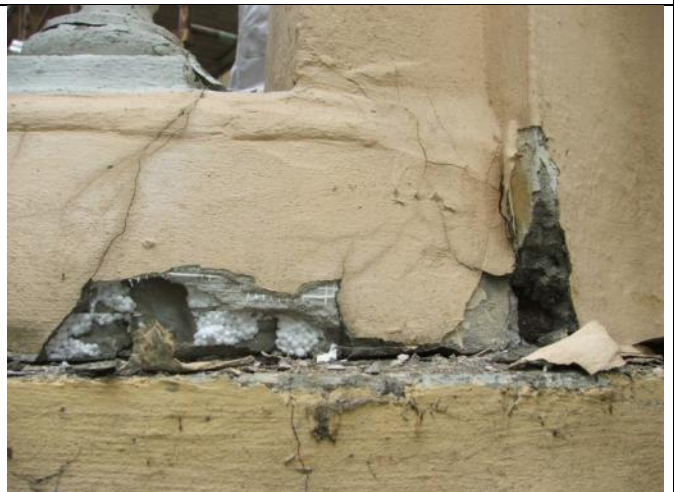
Figure 34 – fragment of the terrace wall

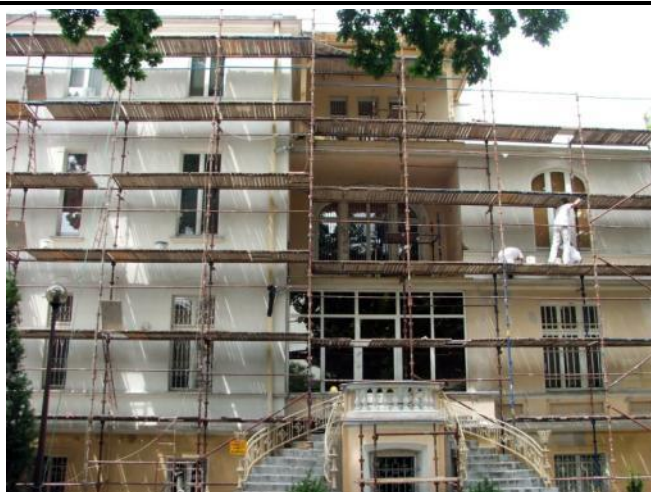
Figure 37 – the east wall of the school building (1.07.2014)

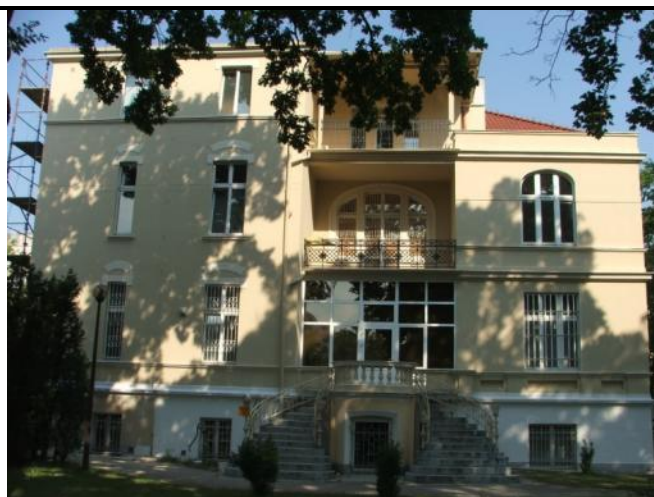
Figure 38 – the east wall of the school building (18.07.2014)

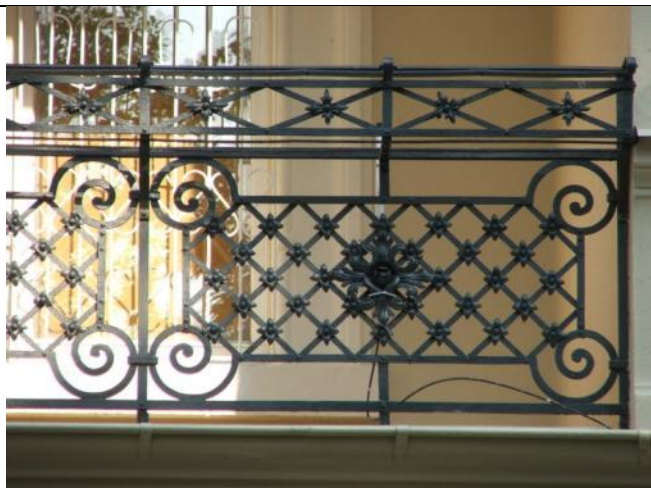
Figure 39 - balcony balustrade after sandblasting and painting – on the 1<sup>st</sup> floor

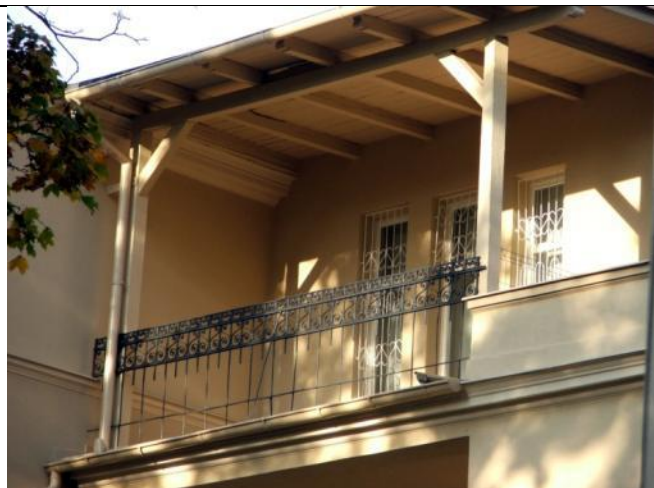
Figure 40 - balcony balustrade after sandblasting and painting – on the 2<sup>nd</sup> floor

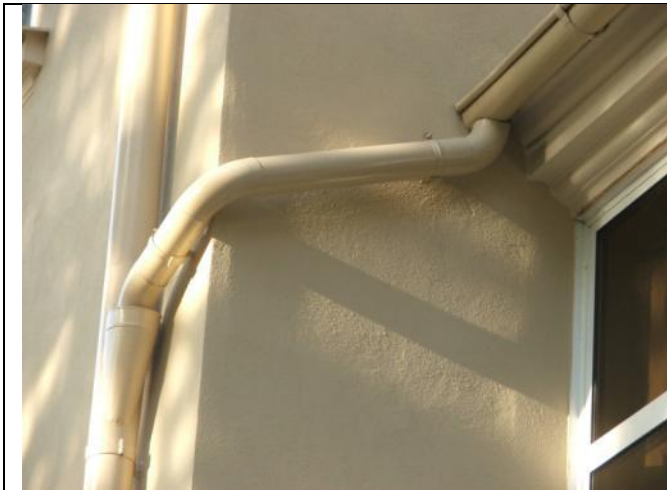
Figure 41 – flumes on the east wall of the building

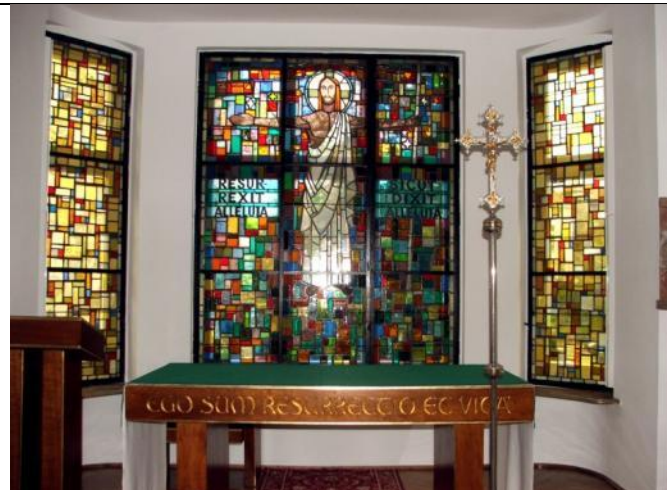
Figure 42 - the chapel stained glass-windows, after reparation

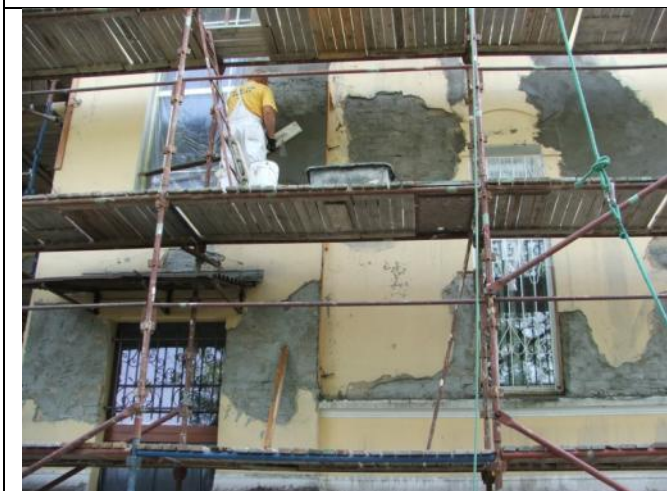
Figure 43 – repair works on the south wall (18.07.2014)

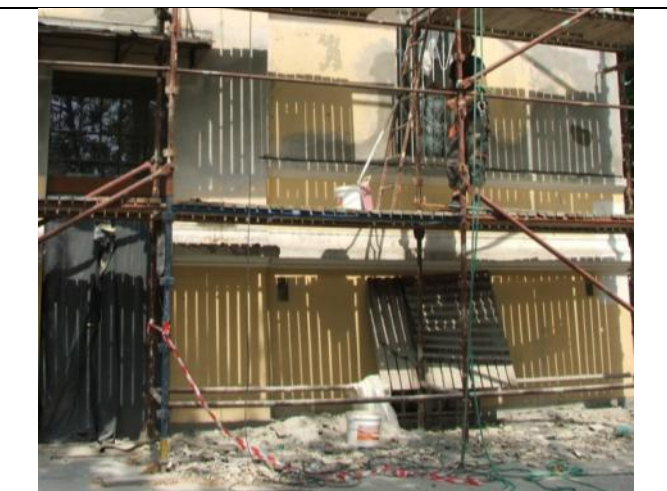
Figure 44 – repair works on the south wall (22.07.2014)

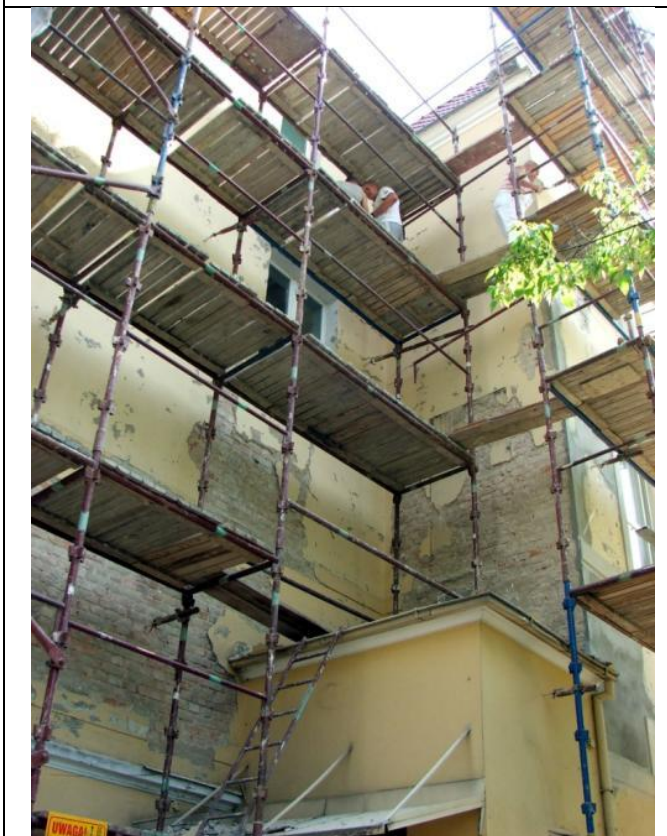
Figure 45– repair works on the south wall (29.07.2014)

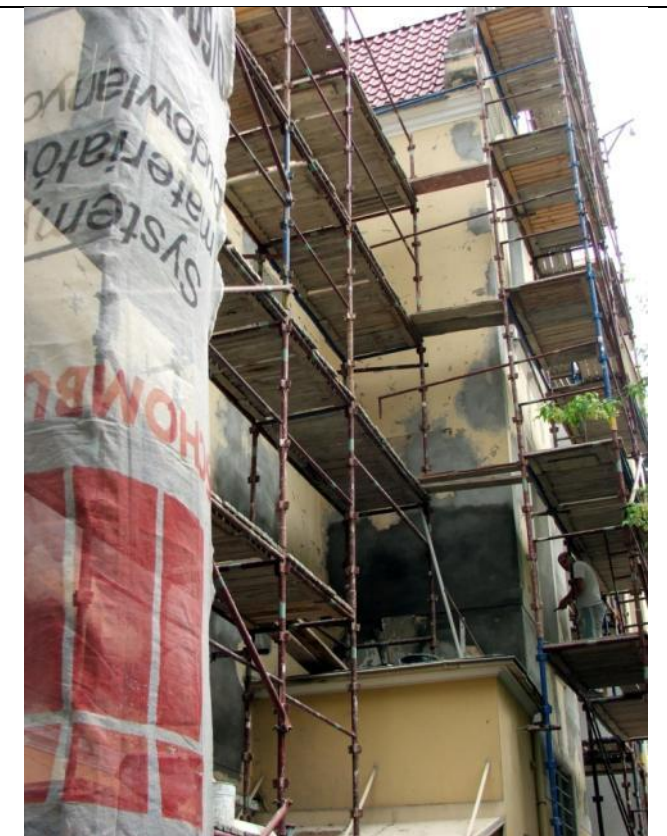
Figure 46 – repair works on the south wall (31.07.2014)

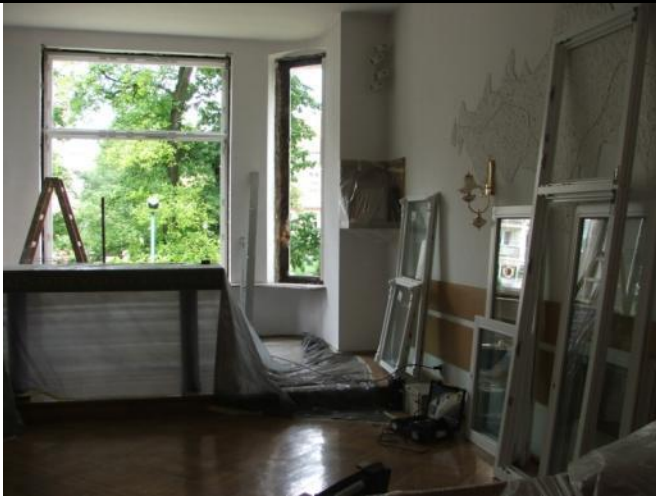
Figure 47 – changing chapel windows (1.08.2014)

1. The changing of the chapel windows – applying antiburglar window pane (type P2 )and removing window bars.
2. Woodworks and roofing works in the school garage.
3. Damp-course treatment of stairways and floor of the terrace .
4. Installation new waterproof concreted band surrounded the building and cleaning ventilation gratings on the base course of a building.
5. Continuation of repair works on the base course of a building.
6. Heating bars and balustrades of the terrace, making some alterations to the repair works, putting the school terrain in order.

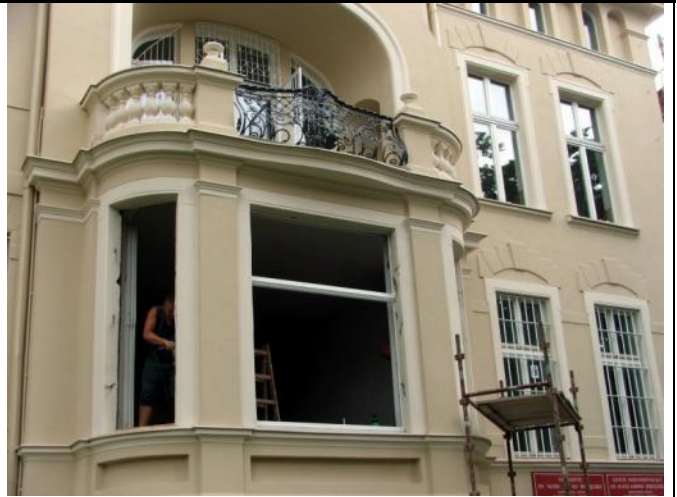
Figure 48 – changing chapel windows (1.08.2014)

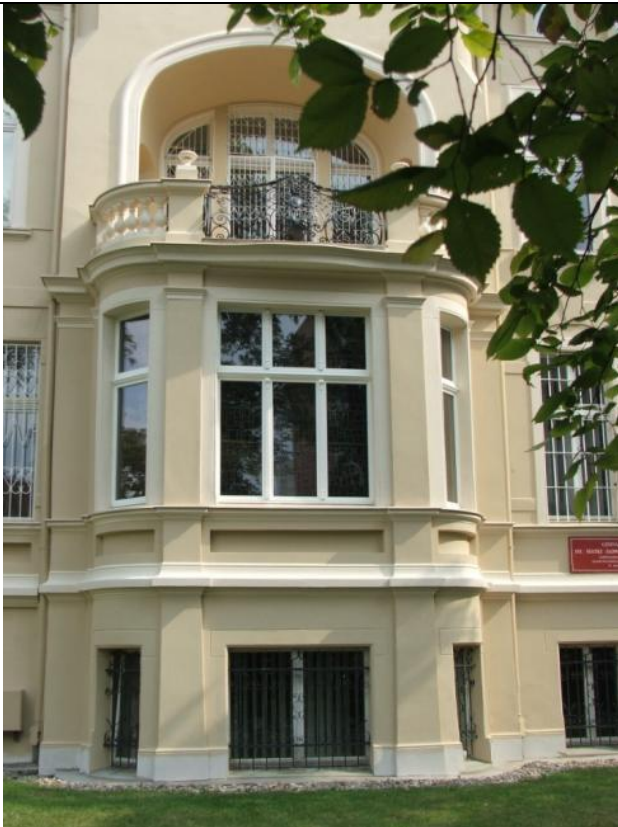
Figure 49 – facade of the school after changing chapel windows

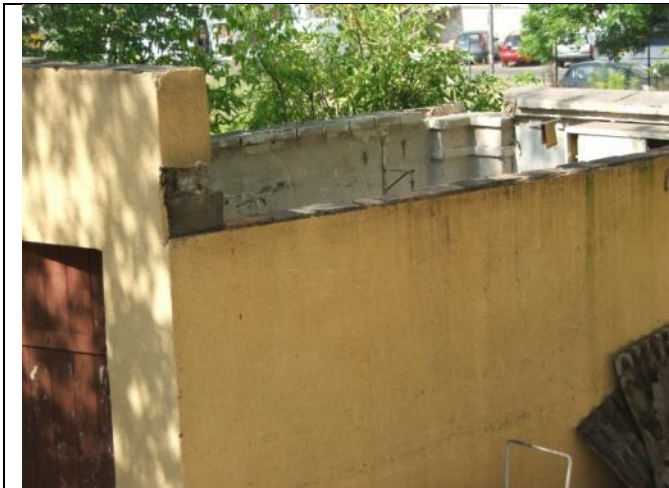
Figure 51 – renovation of garage – removing the roof

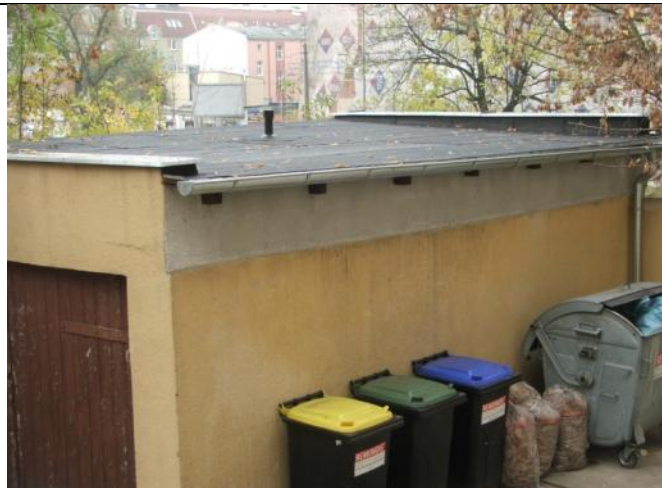
Figure 52 - renovation of garage – the new roof

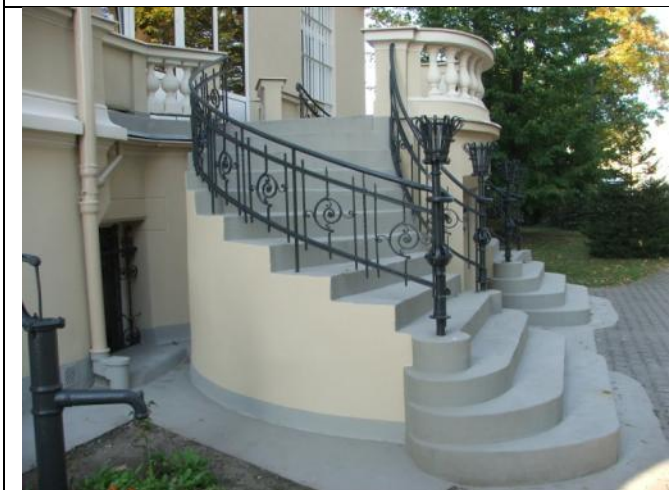
Figure 55– the terrace after repair works

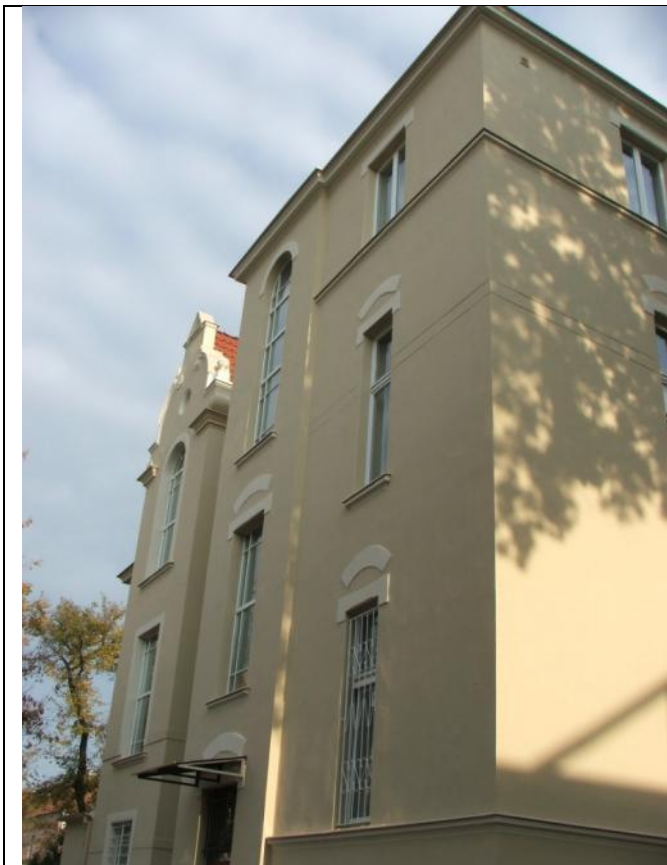
Figure 57 – the south wall of the building after repair works

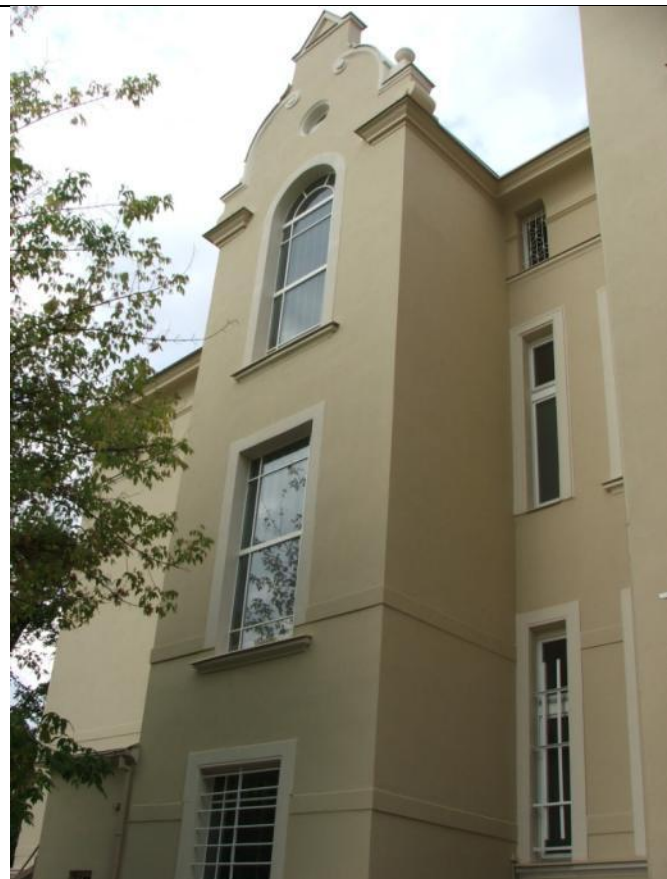
Figure 58 – the south wall of the building after repair works

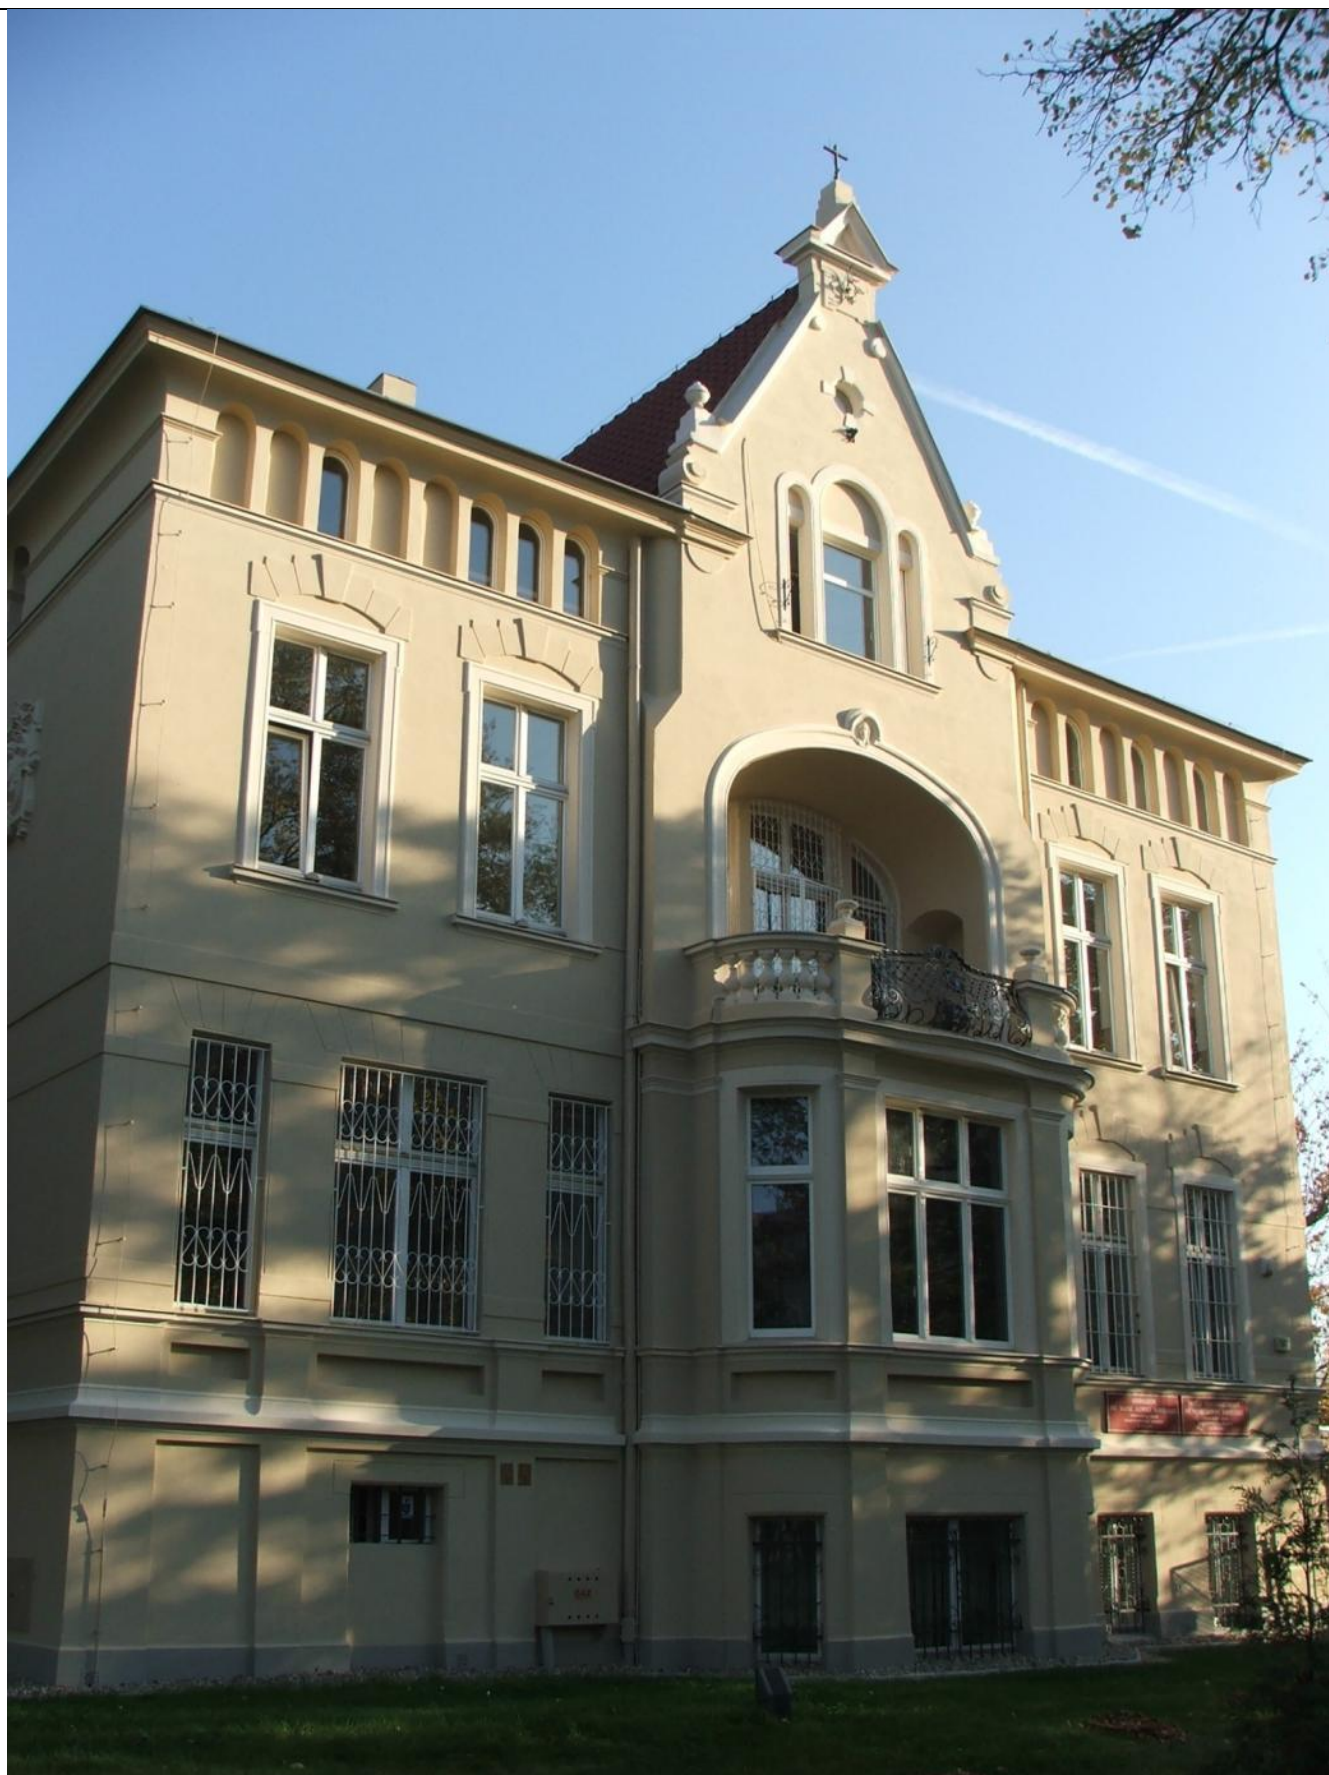
Figure 1. West view of building after renovation

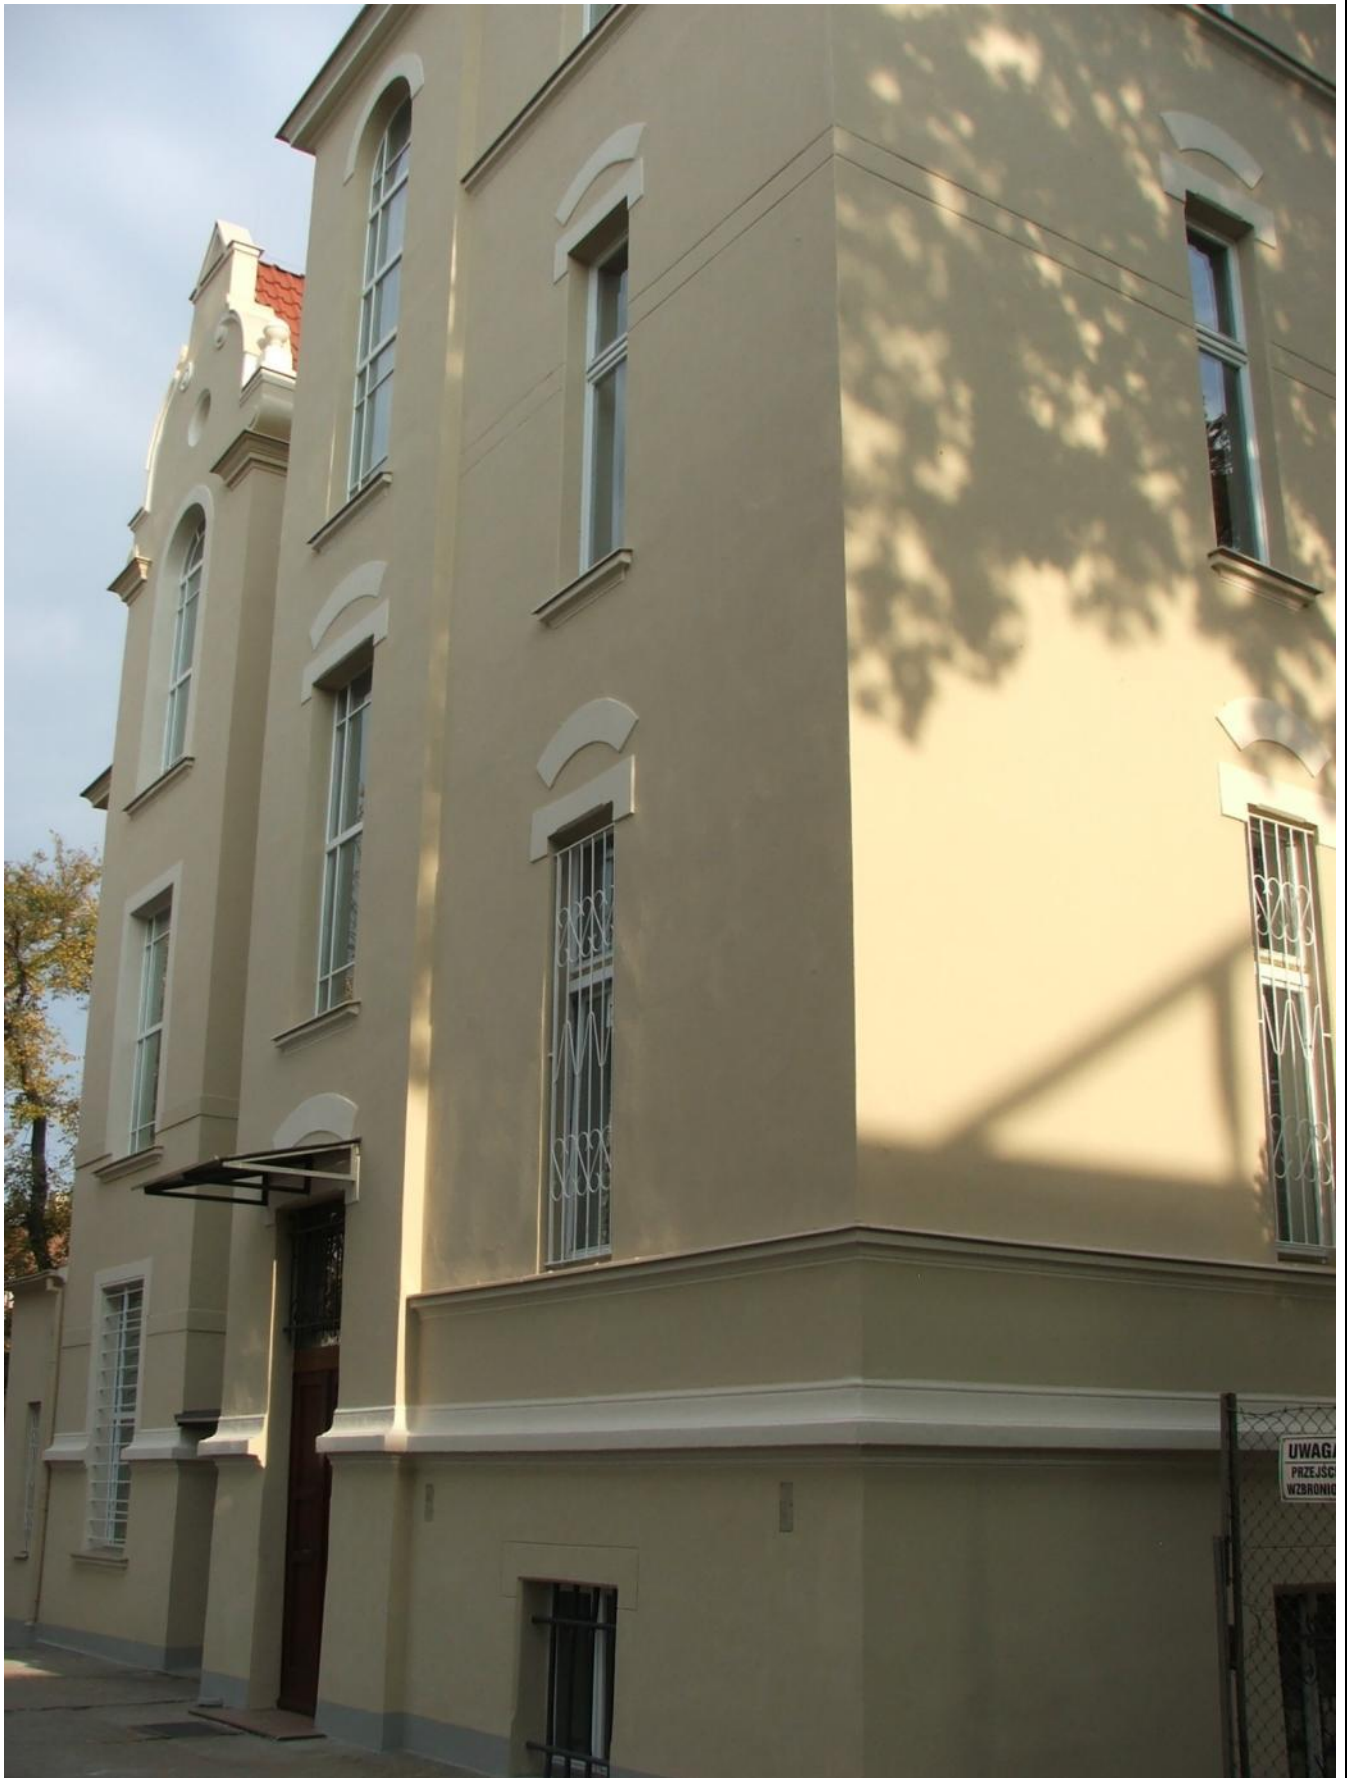
Figure 2. South view of building after renovation

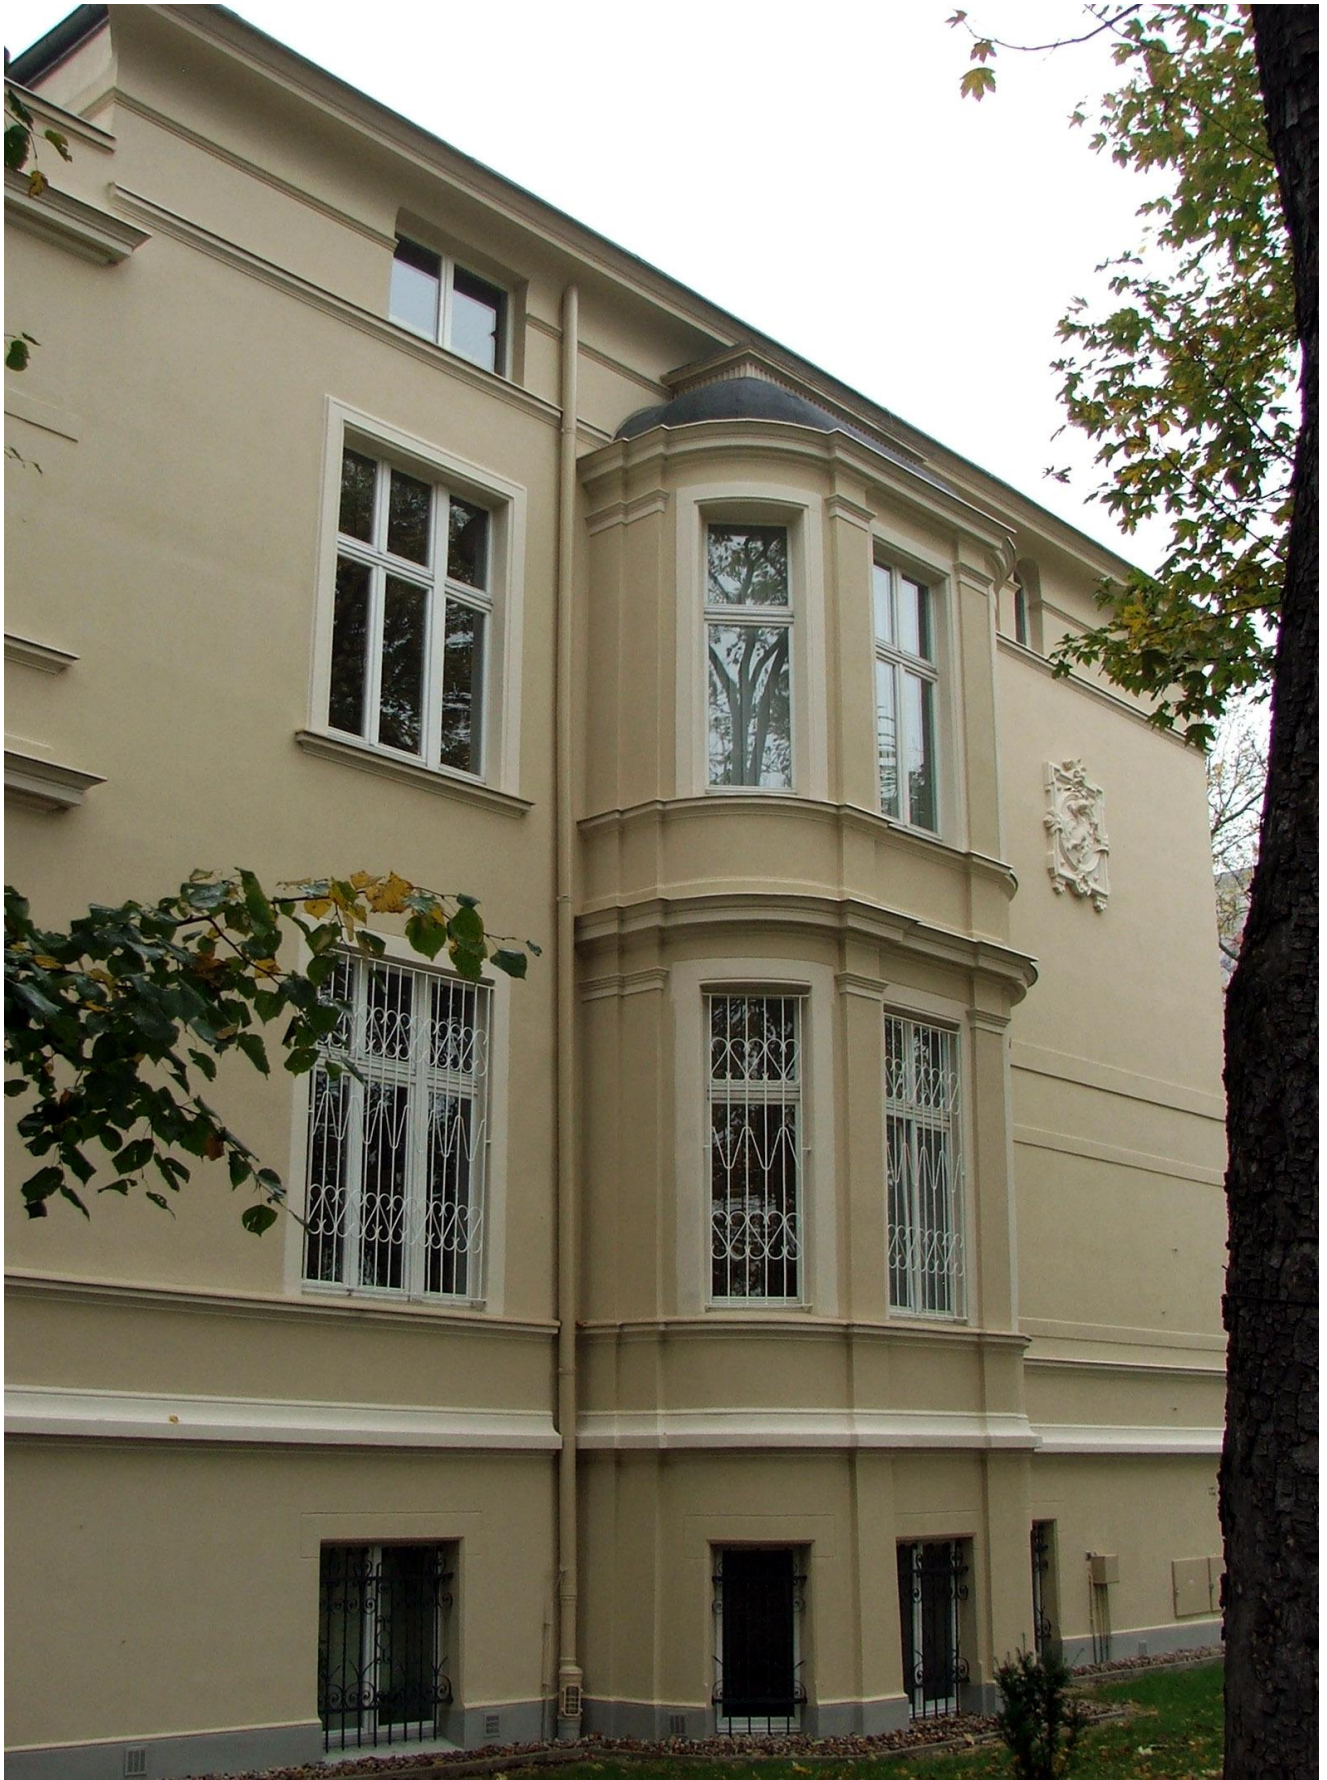
Figure 3. North view of building after renovation

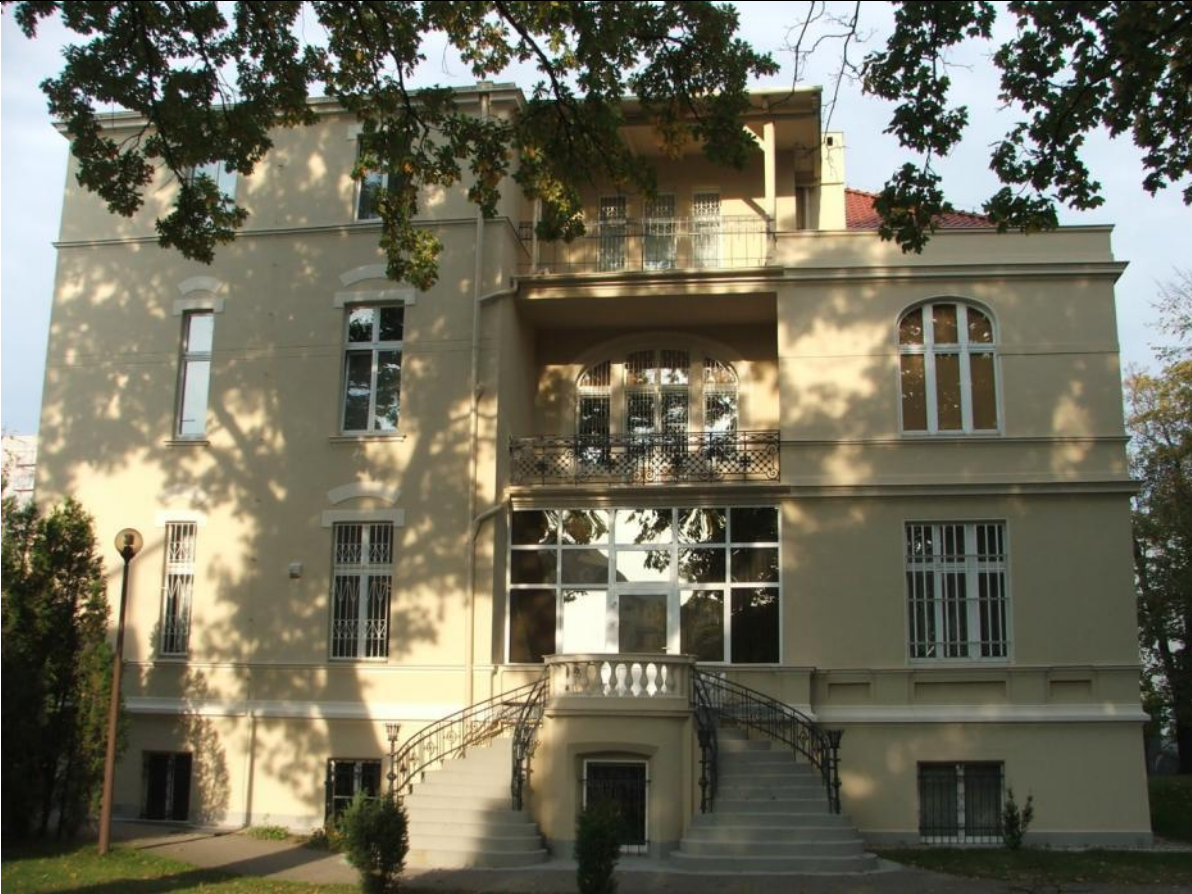
**Figure 4. North view of building after renovation**
